Alcona Black River & Coastal Watersheds 2011 Watershed Management Plan

Northeast Michigan Council of Governments

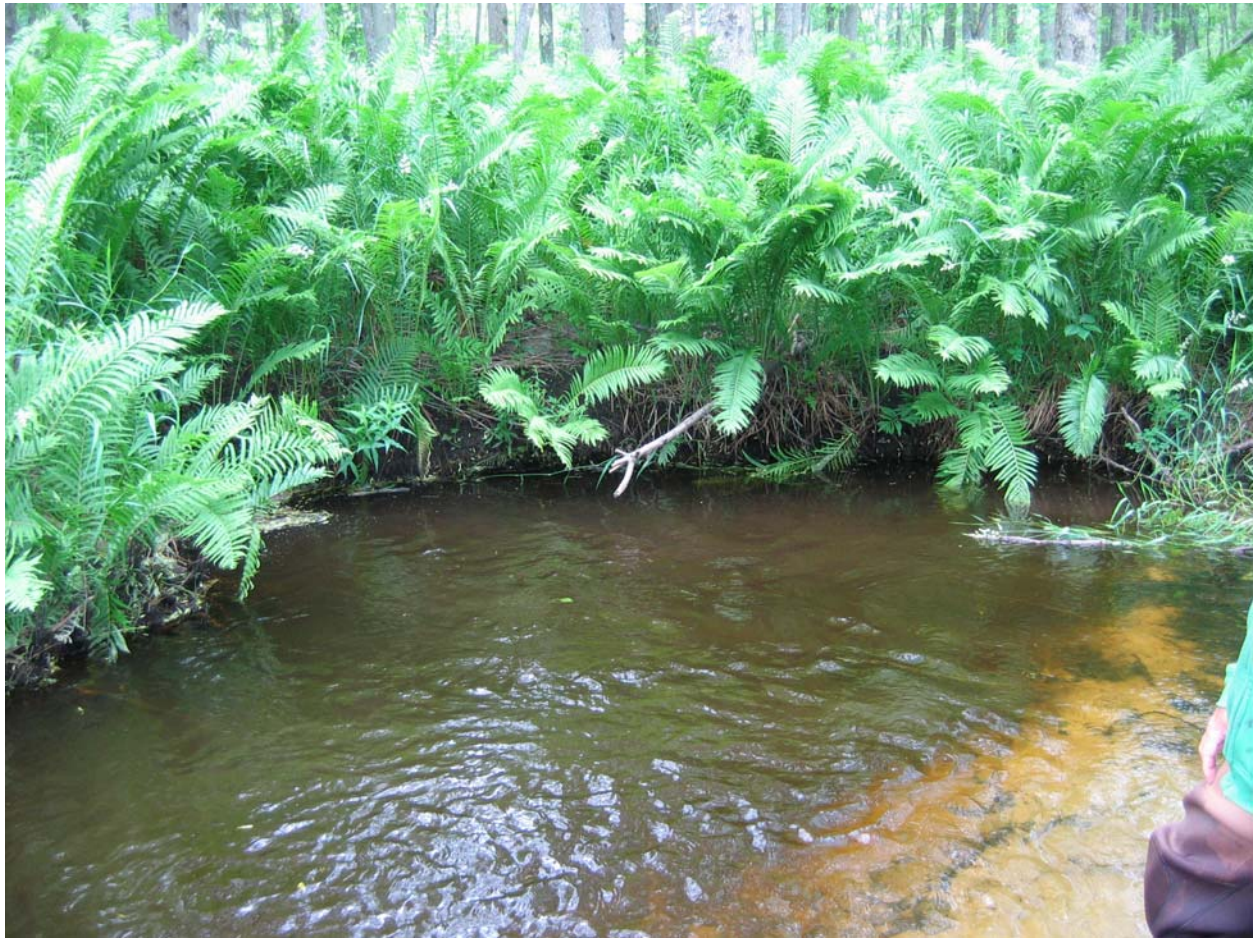
Site ID	SB01		Severity Rating:	Minor
County:	Alcona		Water Feature:	N Branch Black River
Township:	Alcona T28N 9E Sec 22		Landowners:	Private
Condition of Bank:	Toe is undercutting	Apparent Cause of Erosion:	Bend in river, log jam	
Problem Trend:	Increasing			
Side Slope of Bank:	Vertical			
Length of Eroded Bank:	16 feet			
Depth of River:	1 foot			
Soil Type/Texture:	Loam/Muck	Recommended Treatment:	Reposition log jam Brush placement	
Vegetation on Bank Slope:	50-100%			
Height of Eroded Bank:	2 feet			
Current:	Slow	Estimated Cost:	\$500

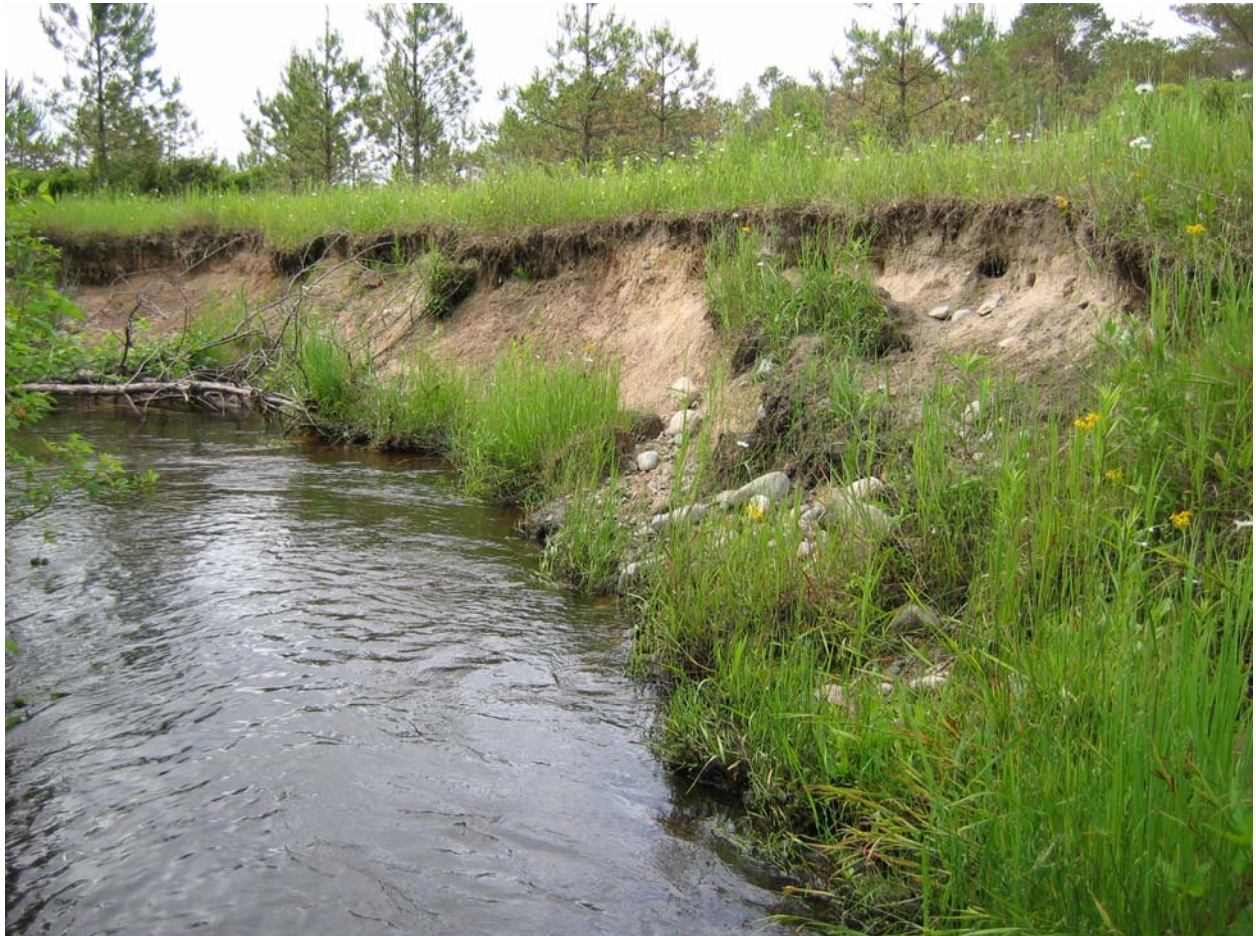
Site ID	SB02		Severity Rating:	Severe
County:	Alcona		Water Feature:	N Branch Black River
Township:	Alcona T28N 9E Sec 22		Landowners:	Private
Condition of Bank:	Toe & upper bank eroding	Apparent Cause of Erosion:	Bend in river Land use Foot traffic	
Problem Trend:	Increasing			
Side Slope of Bank:	1:1			
Length of Eroded Bank:	175 feet			
Depth of River:	3 feet			
Soil Type/Texture:	Sand over clay	Recommended Treatment:	Bank Sloping Log terrace Biolog/tree revetment Bank seeding & planting	
Vegetation on Bank Slope:	0-10%			
Height of Eroded Bank:	7 feet			
Current:	Moderate	Estimated Cost:	\$12,250

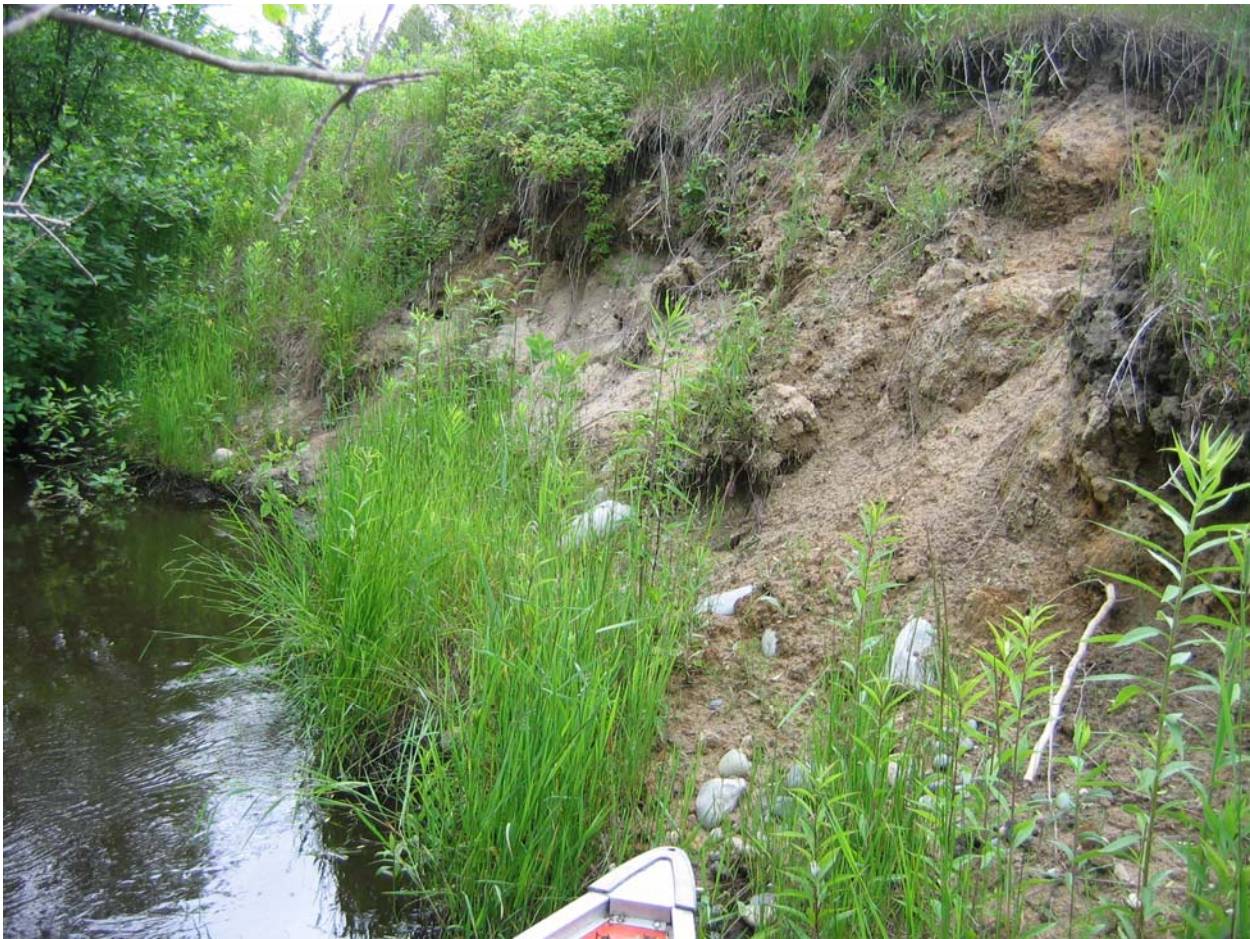
Site ID	SB03	Severity Rating:	Severe
County:	Alcona	Water Feature:	N Branch Black River
Township:	Alcona T28N 9E Sec 22	Landowners:	Private
Condition of Bank:	Toe & upper bank eroding	Apparent Cause of Erosion:	Bend in river Land use Foot traffic Wildlife use
Problem Trend:	Increasing		
Side Slope of Bank:	1:1		
Length of Eroded Bank:	200 feet		
Depth of River:	1 foot		
Soil Type/Texture:	Sand over clay	Recommended Treatment:	Bank sloping Biolog/tree revetment Bank seeding & planting
Vegetation on Bank Slope:	10-50%		
Height of Eroded Bank:	9 feet		
Current:	Slow	Estimated Cost:	\$14,000

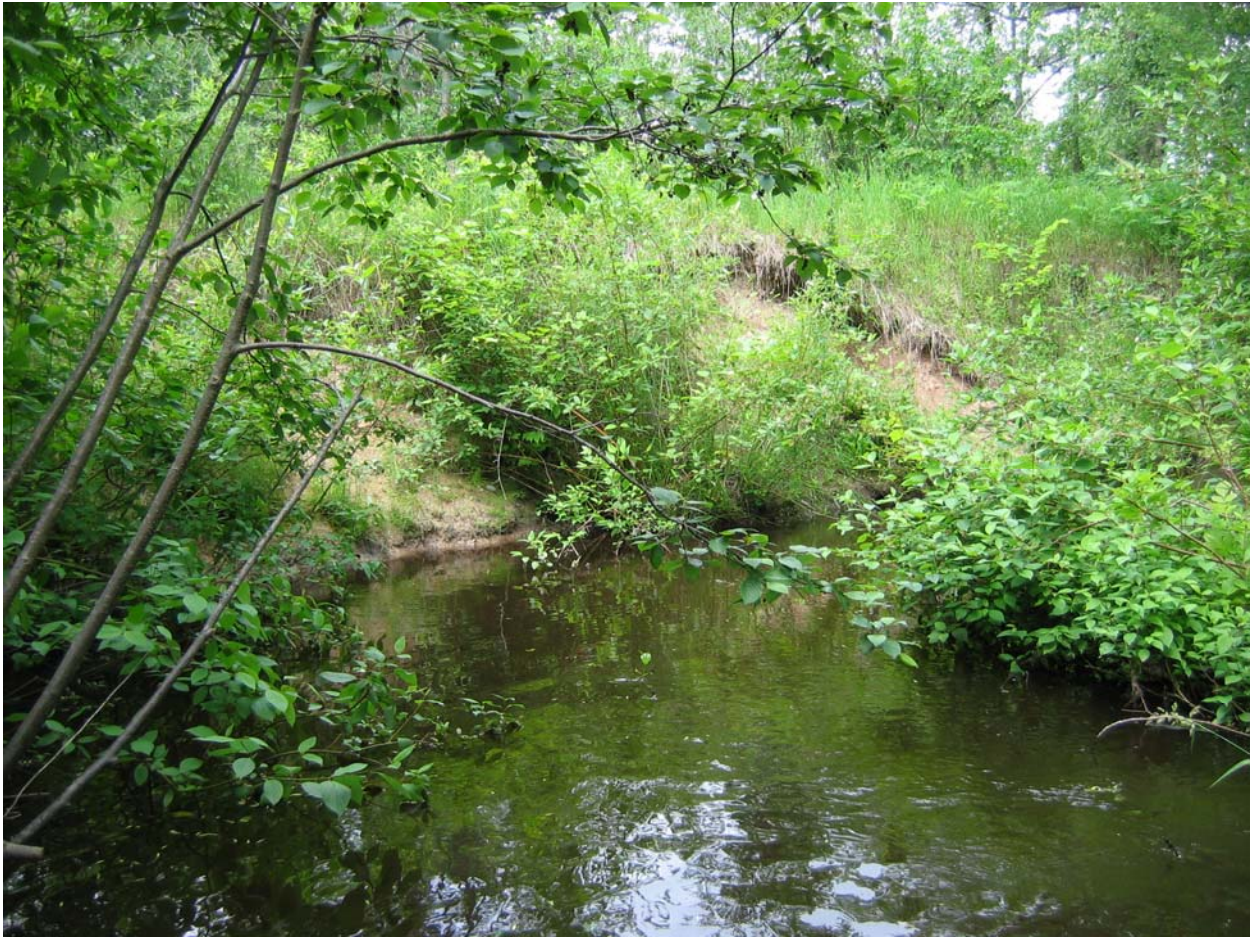
Site ID	SB04	Severity Rating:	Moderate
County:	Alcona	Water Feature:	N Branch Black River
Township:	Alcona T28N 9E Sec 22	Landowners:	Private
Condition of Bank:	Toe & upper bank eroding	Apparent Cause of Erosion:	Bend in river Land use
Problem Trend:	Stable		
Side Slope of Bank:	1:1		
Length of Eroded Bank:	125 feet		
Depth of River:	4 feet		
Soil Type/Texture:	Sand over clay	Recommended Treatment:	Bank sloping or log terrace Biolog/tree revetment Bank seeding & planting
Vegetation on Bank Slope:	10-50%		
Height of Eroded Bank:	9 feet		
Current:	Slow	Estimated Cost:	\$8,750

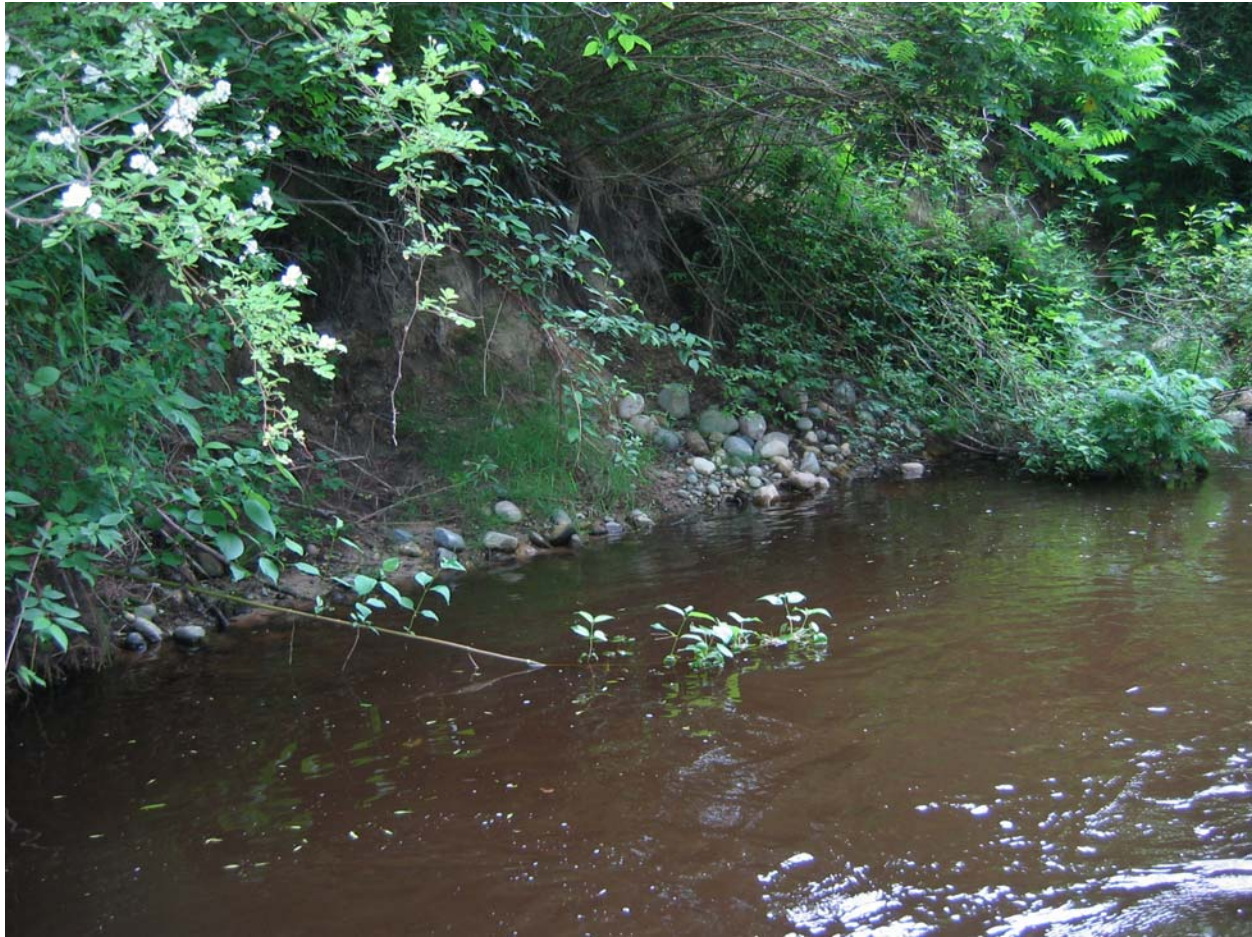
Site ID	SB05	Severity Rating:	Moderate
County:	Alcona	Water Feature:	N Branch Black River
Township:	Alcona T28N 9E Sec 22	Landowners:	Private
Condition of Bank:	Toe & upper bank eroding	Apparent Cause of Erosion:	Bend in river Bank seepage
Problem Trend:	Increasing		
Side Slope of Bank:	1:1		
Length of Eroded Bank:	125 feet		
Depth of River:	2 feet		
Soil Type/Texture:	Sand over clay	Recommended Treatment:	Bank sloping or log terrace Biolog/tree revetment Bank seeding & planting
Vegetation on Bank Slope:	50-100%		
Height of Eroded Bank:	9 feet		
Current:	Slow	Estimated Cost:	\$6,250

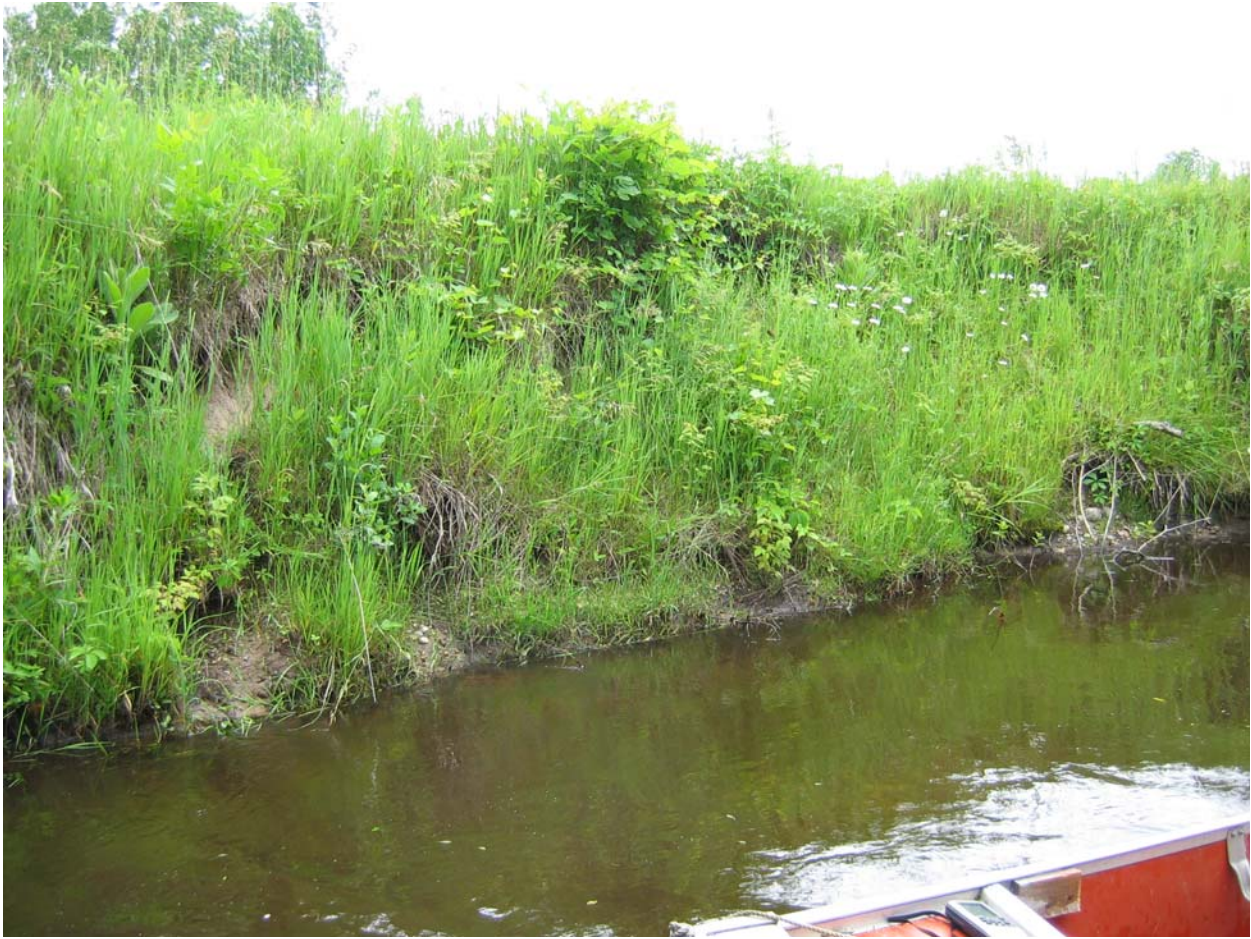
Site ID	SB06	Severity Rating:	Minor
County:	Alcona	Water Feature:	N Branch Black River
Township:	Alcona T28N 9E Sec 22	Landowners:	Private
Condition of Bank:	Toe & upper bank eroding	Apparent Cause of Erosion:	Bend in river Land use
Problem Trend:	Stable		
Side Slope of Bank:	1:1		
Length of Eroded Bank:	125 feet		
Depth of River:	2 feet		
Soil Type/Texture:	Sand & gravel	Recommended Treatment:	Bank sloping or log terrace Biolog/tree revetment Bank seeding & planting
Vegetation on Bank Slope:	50-100%		
Height of Eroded Bank:	8 feet		
Current:	Moderate	Estimated Cost:	\$6,250

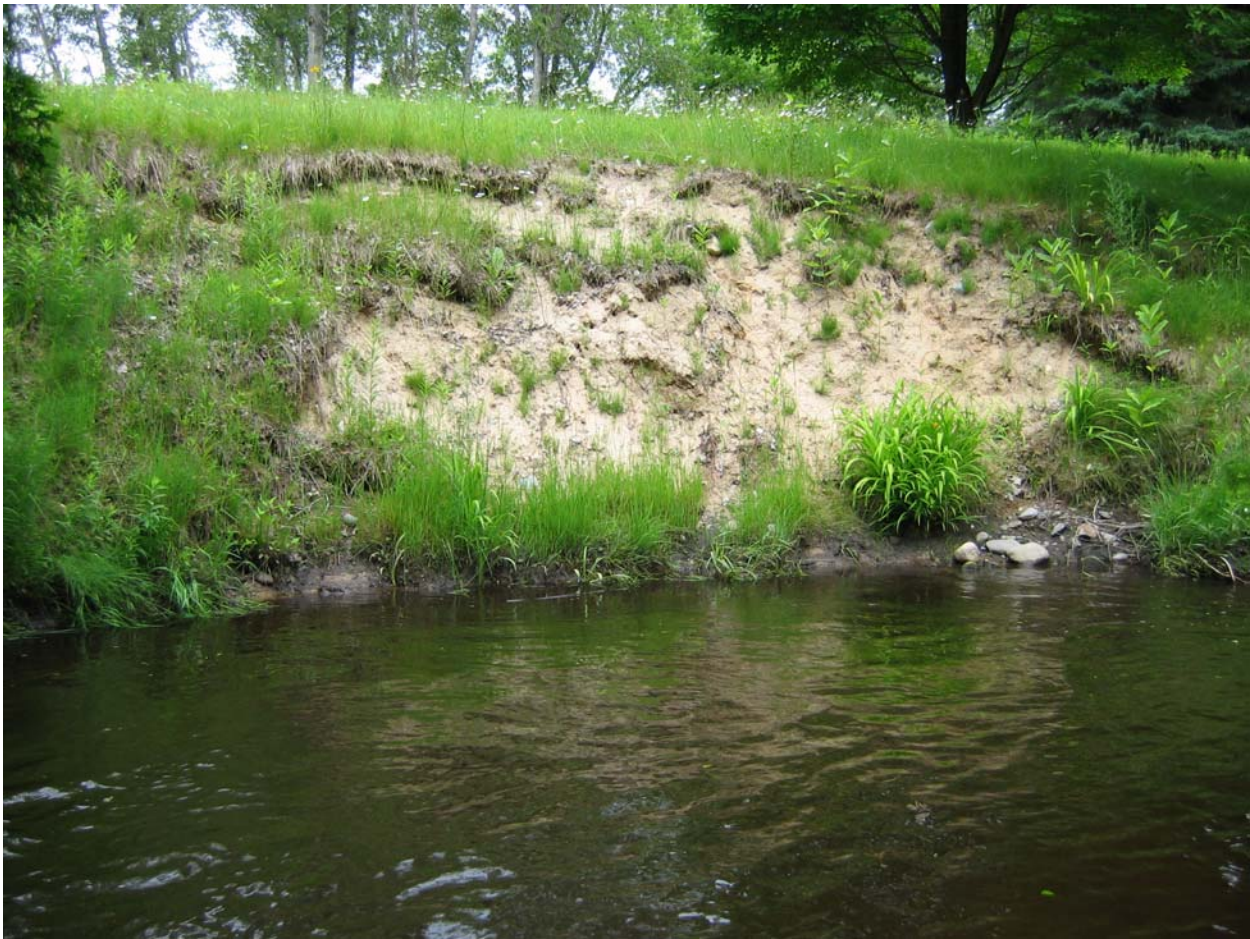
Site ID	SB07	Severity Rating:	Moderate
County:	Alcona	Water Feature:	Black River
Township:	Alcona T28N 9E Sec 22	Landowners:	Private
Condition of Bank:	Toe & upper bank eroding	Apparent Cause of Erosion:	Bend/obstruction in river Land use Foot traffic
Problem Trend:	Increasing		
Side Slope of Bank:	1:1		
Length of Eroded Bank:	80 feet		
Depth of River:	2 feet		
Soil Type/Texture:	Sand	Recommended Treatment:	Bank sloping Biolog/tree revetment Bank seeding & planting Remove old dock & stairs from river
Vegetation on Bank Slope:	10-50%		
Height of Eroded Bank:	10 feet		
Current:	Slow	Estimated Cost:	\$4,000

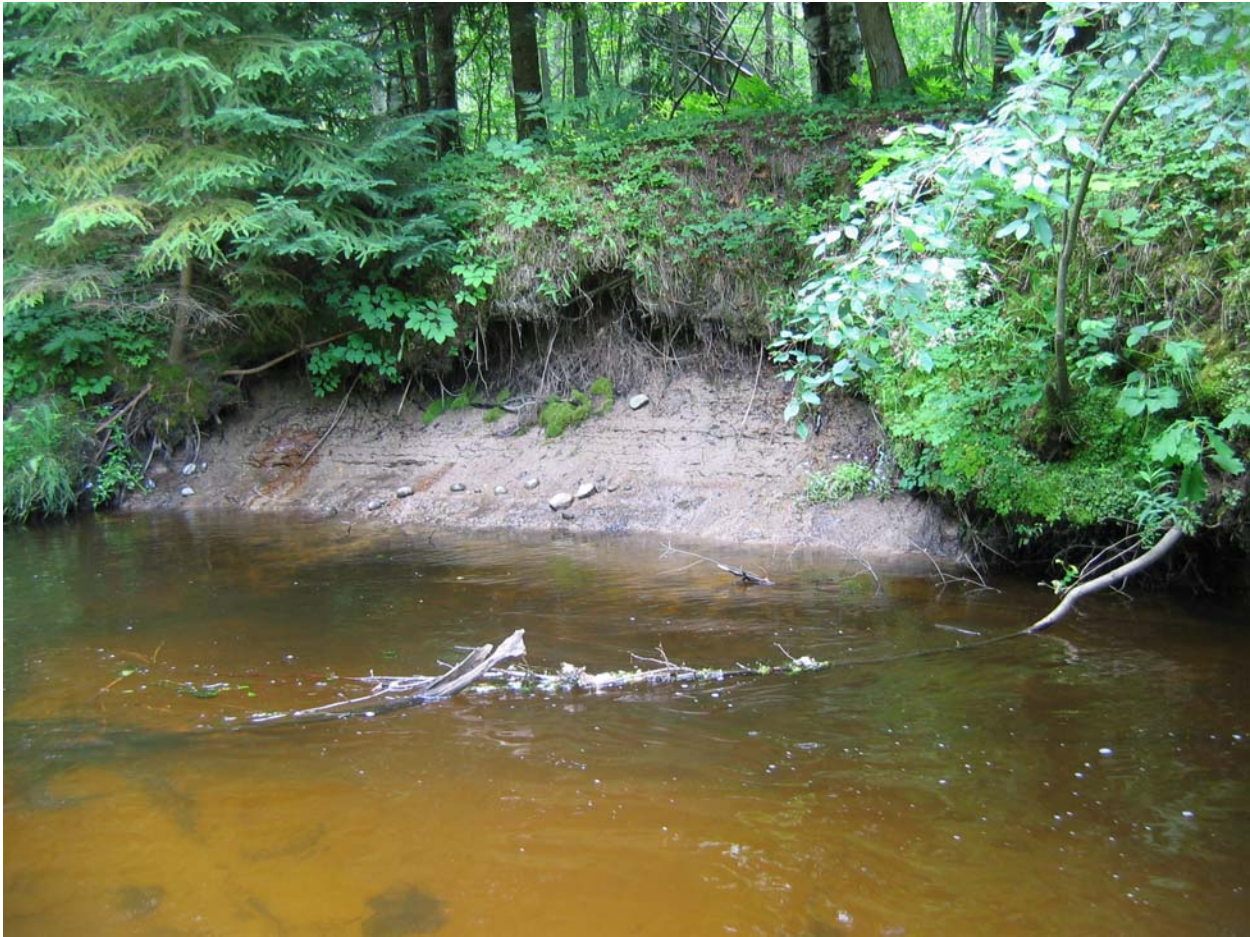
Site ID	SB08	Severity Rating:	Moderate
County:	Alcona	Water Feature:	Black River
Township:	Alcona T28N 9E Sec 23	Landowners:	Private
Condition of Bank:	Toe & upper bank eroding	Apparent Cause of Erosion:	Bend/obstruction in river Bank seepage
Problem Trend:	Stable		
Side Slope of Bank:	1:1		
Length of Eroded Bank:	100 feet		
Depth of River:	2 feet		
Soil Type/Texture:	Clay	Recommended Treatment:	Bank sloping Biolog/tree revetment Topsoil bank and seed & plant
Vegetation on Bank Slope:	0-10%		
Height of Eroded Bank:	10 feet		
Current:	Moderate	Estimated Cost:	\$7,000

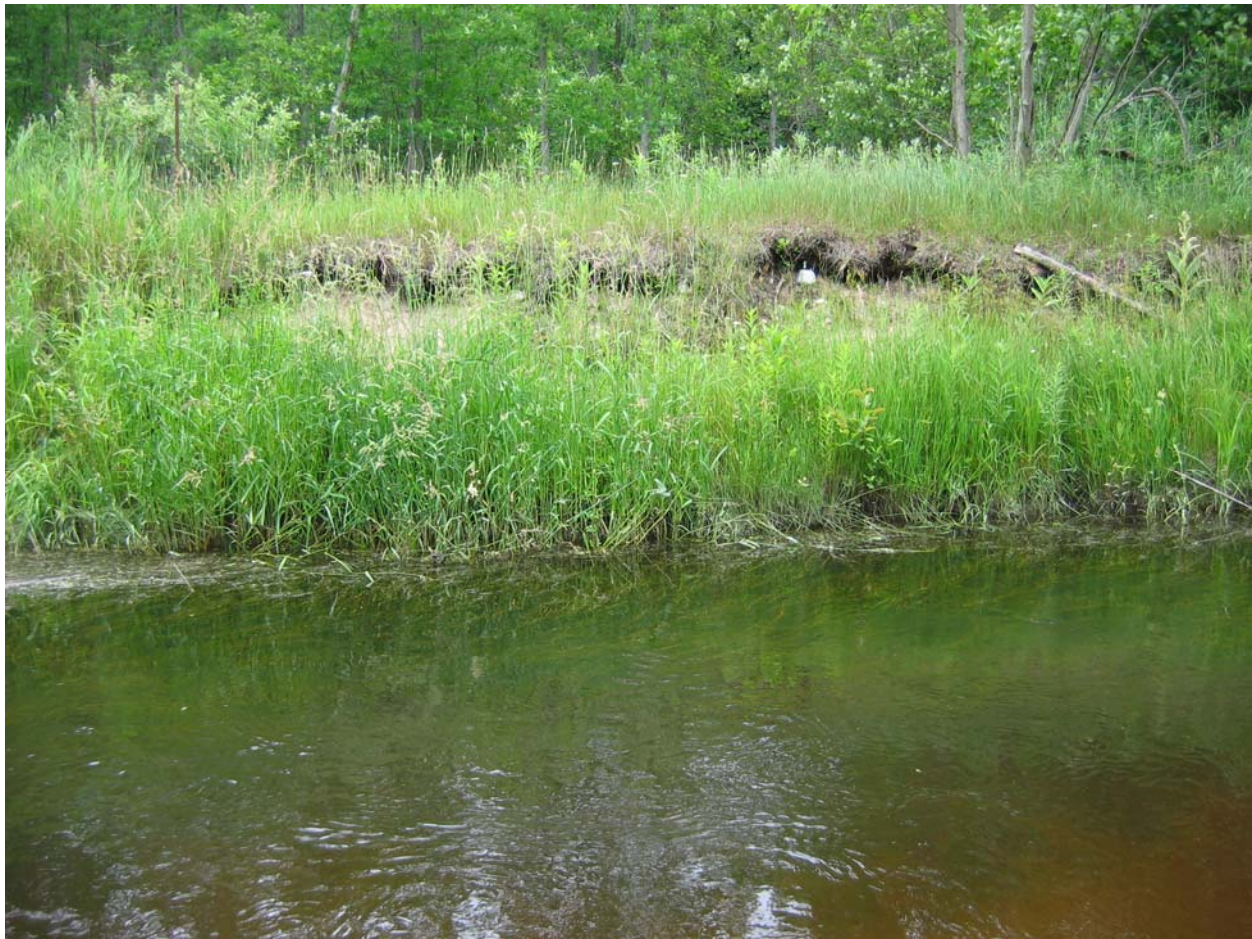
Site ID	SB09	Severity Rating:	Moderate
County:	Alcona	Water Feature:	Black River
Township:	Alcona T28N 9E Sec 23	Landowners:	Private
Condition of Bank:	Upper bank eroding	Apparent Cause of Erosion:	Bend in river Land use Surface water entering
Problem Trend:	Increasing		
Side Slope of Bank:	1:1		
Length of Eroded Bank:	200 feet		
Depth of River:	2 feet		
Soil Type/Texture:	Sand over clay	Recommended Treatment:	Bank sloping Biolog/tree revetment Bank seeding & planting
Vegetation on Bank Slope:	10-50%		
Height of Eroded Bank:	6 feet		
Current:	Moderate	Estimated Cost:	\$14,000

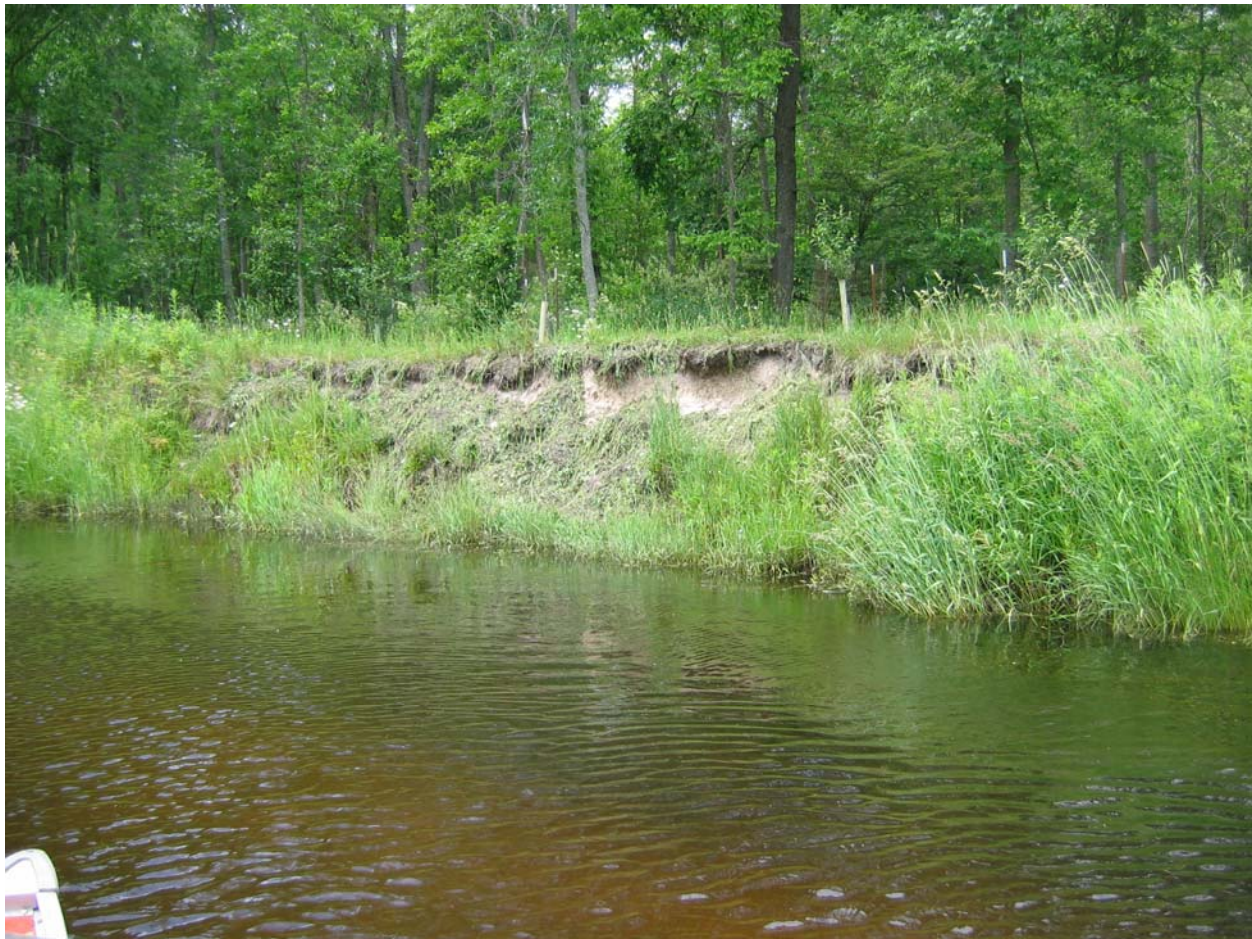
Site ID	SB10	Severity Rating:	Moderate
County:	Alcona	Water Feature:	Black River
Township:	Alcona T28N 9E Sec 22	Landowners:	Private
Condition of Bank:	Upper bank eroding	Apparent Cause of Erosion:	Bend/obstruction in river Land use Foot traffic Surface water entering Bank seepage
Problem Trend:	Increasing		
Side Slope of Bank:	1:1		
Length of Eroded Bank:	150 feet		
Depth of River:	3 feet		
Soil Type/Texture:	Sand over clay	Recommended Treatment:	Bank sloping Biolog/tree revetment Bank seeding & planting Brush placement
Vegetation on Bank Slope:	10-50%		
Height of Eroded Bank:	6 feet		
Current:	Moderate	Estimated Cost:	\$10,500

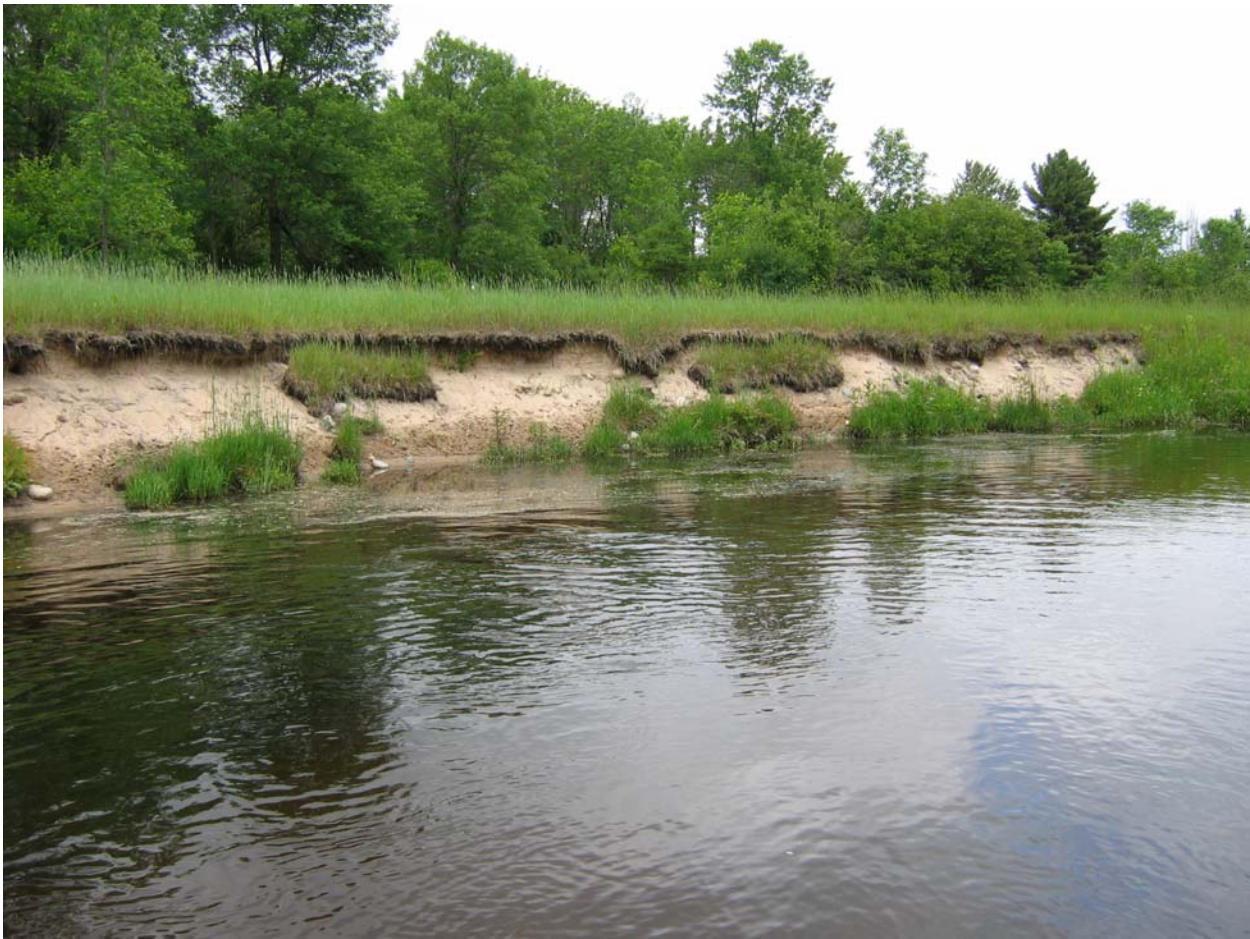
Site ID	SB11	Severity Rating:	Severe
County:	Alcona	Water Feature:	Black River
Township:	Alcona T28N 9E Sec 23	Landowners:	Private
Condition of Bank:	Toe & upper bank eroding	Apparent Cause of Erosion:	Bend in river Land use Wave action Surface water entering Bank Seepage
Problem Trend:	Increasing		
Side Slope of Bank:	1:1		
Length of Eroded Bank:	400 feet		
Depth of River:	3 feet		
Soil Type/Texture:	Sand	Recommended Treatment:	Bank sloping Biolog/tree revetment Bank seeding & planting Brush placement
Vegetation on Bank Slope:	0-10%		
Height of Eroded Bank:	6 feet		
Current:	Moderate	Estimated Cost:	\$28,000

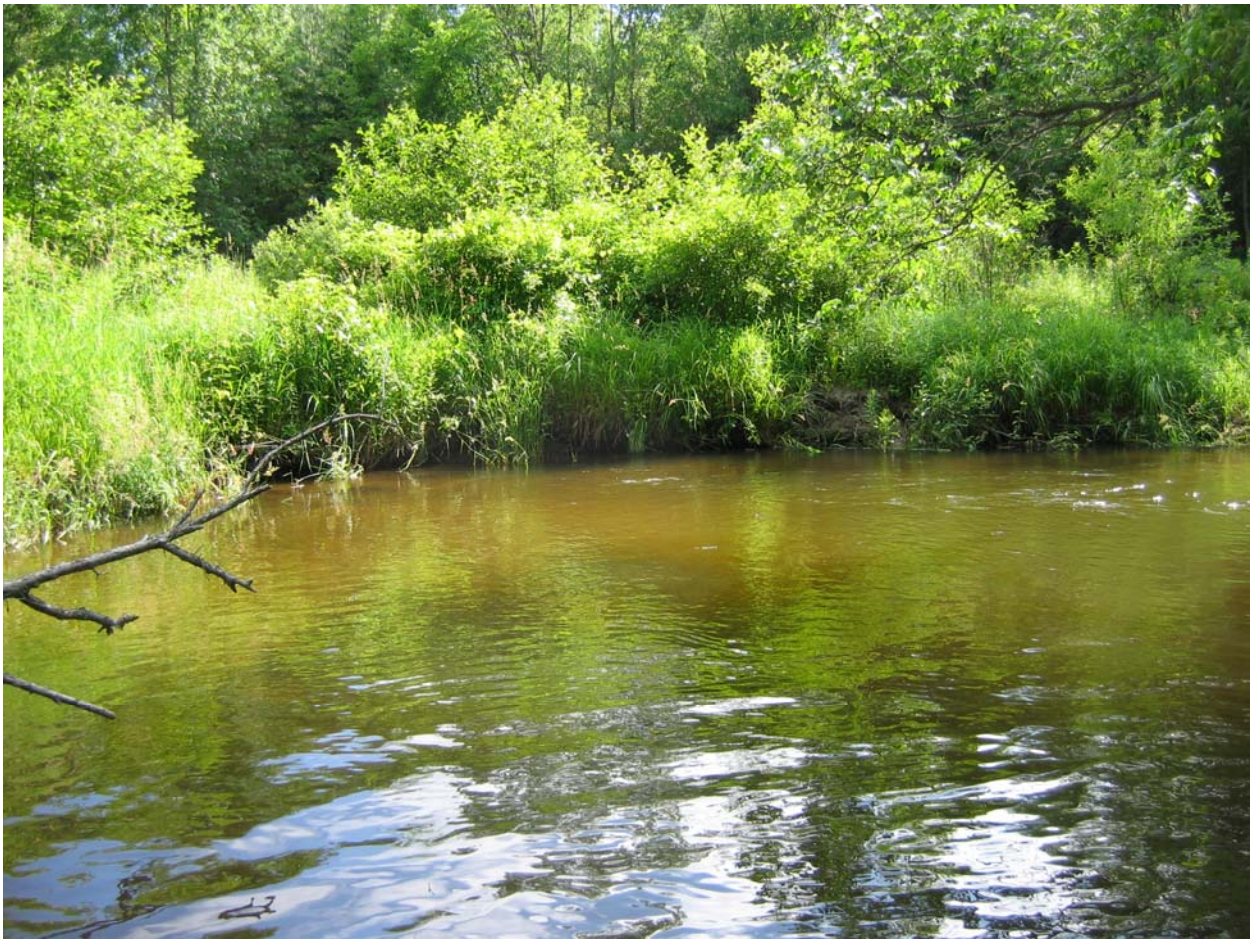
Site ID	SB12	Severity Rating:	Moderate
County:	Alcona	Water Feature:	S Branch Black River
Township:	Alcona T28N 9E Sec 26	Landowners:	Private
Condition of Bank:	Toe is undercutting	Apparent Cause of Erosion:	Bend/obstruction in river Land use Foot traffic
Problem Trend:	Increasing		
Side Slope of Bank:	Vertical		
Length of Eroded Bank:	120 feet		
Depth of River:	2 feet		
Soil Type/Texture:	Sand (loamy sand)	Recommended Treatment:	LUNKER Structure Rock rip rap Biolog/tree revetment Bank seeding & planting
Vegetation on Bank Slope:	50-100%		
Height of Eroded Bank:	4 feet		
Current:	Moderate	Estimated Cost:	\$5,225

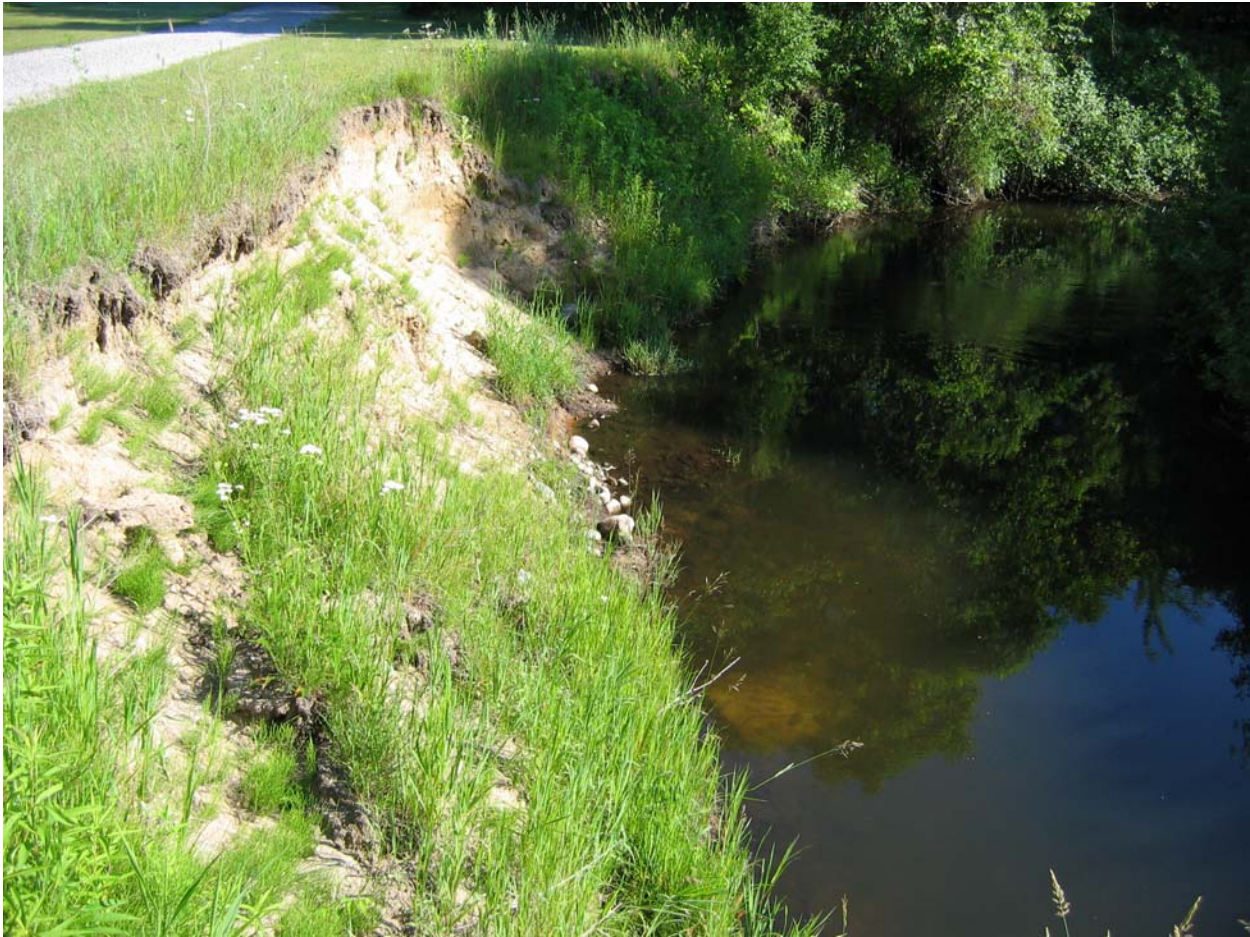
Site ID	SB13	Severity Rating:	Severe
County:	Alcona	Water Feature:	S Branch Black River
Township:	Alcona T28N 9E Sec 22	Landowners:	Private
Condition of Bank:	Toe & upper bank eroding	Apparent Cause of Erosion:	Bend/obstruction in river Land use Foot traffic
Problem Trend:	Increasing		
Side Slope of Bank:	1:1		
Length of Eroded Bank:	175 feet		
Depth of River:	2 feet		
Soil Type/Texture:	Sand	Recommended Treatment:	Bank sloping or log terrace Biolog/tree revetment Bank seeding & planting
Vegetation on Bank Slope:	0-10%		
Height of Eroded Bank:	10 feet		
Current:	Slow	Estimated Cost:	\$12,250

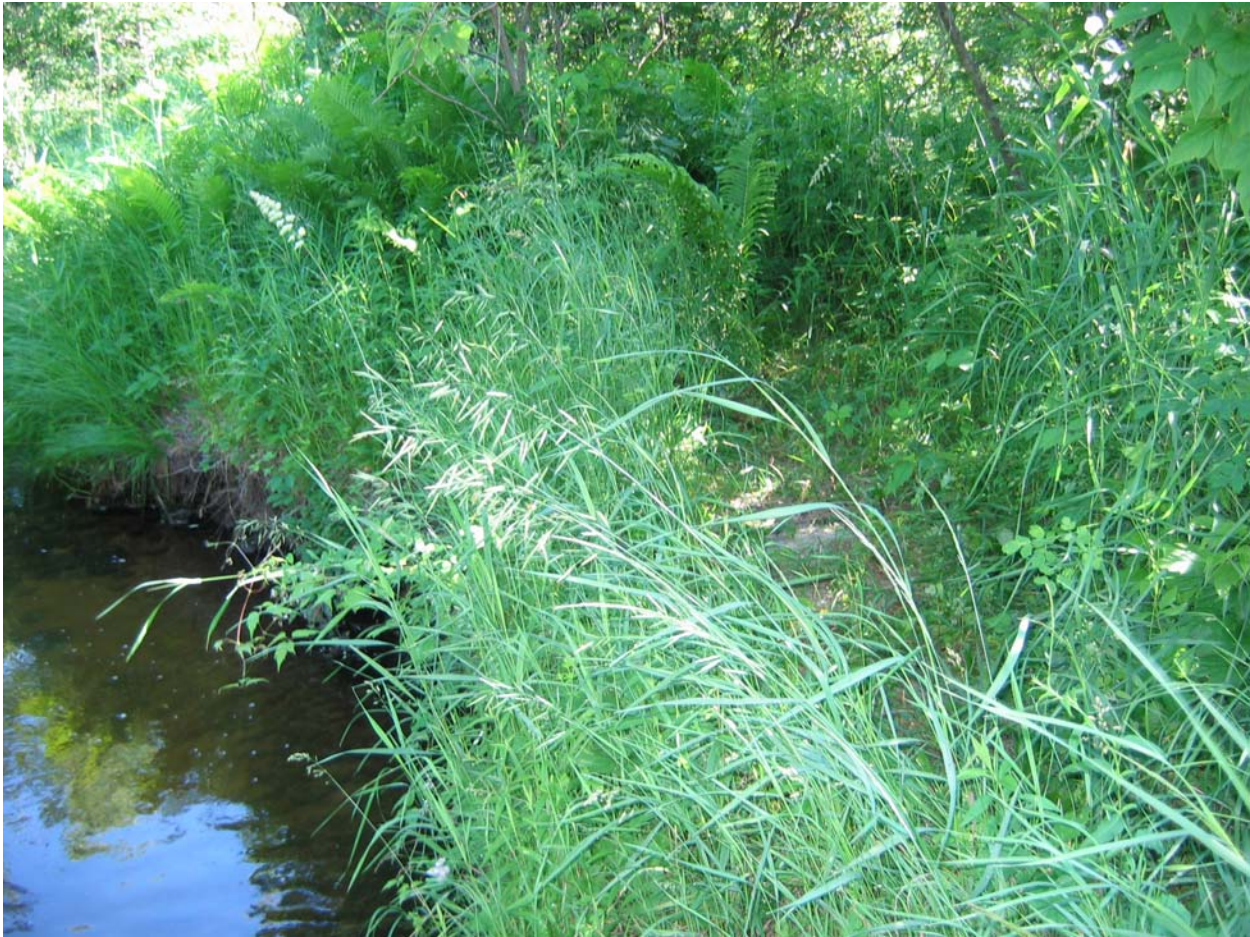
Site ID	SB14	Severity Rating:	Moderate
County:	Alcona	Water Feature:	N & S Branch Black Rv
Township:	Alcona T28N 9E Sec 26	Landowners:	Private
Condition of Bank:	Toe is undercutting	Apparent Cause of Erosion:	Bend/obstruction in river Land use Foot traffic Confluence of N & S Branches Black River
Problem Trend:	Increasing		
Side Slope of Bank:	Vertical		
Length of Eroded Bank:	100 feet		
Depth of River:	4 feet		
Soil Type/Texture:	Sand (loamy sand)	Recommended Treatment:	LUNKER Structure Rock rip rap Bank seeding & planting
Vegetation on Bank Slope:	10-50%		
Height of Eroded Bank:	3 feet		
Current:	Slow	Estimated Cost:	\$6,625

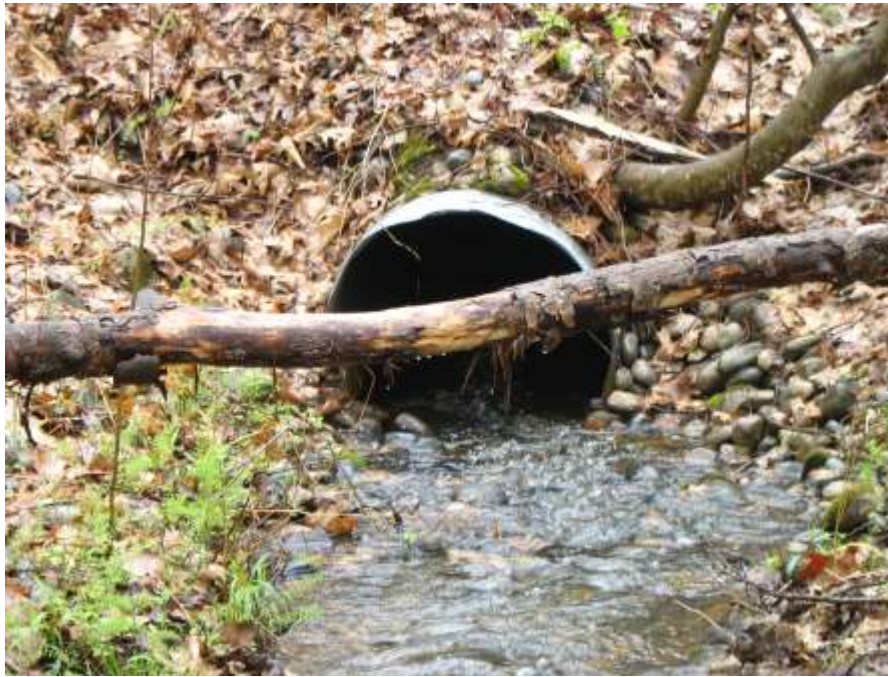
**Location**County: *Alcona*Stream Name: *Gauthier Creek*Road Name: *Bouchard Rd*Township: *Alcona*Adjacent Landowners: *federal***Culvert Description**Crossing Type: *single culvert*Culvert Length (ft): *45*Culvert Diameter (in): *30"*Culvert Condition: *good*Culvert Flow: *perched*Fish Passage Problem: *Yes*Culvert Fill Depth-inlet, outlet (ft): *7, 8*Culvert Embankment Slopes: *1:2, >1:2*Culvert Material: *galvanized***Erosion**Severity Category: *moderate*Erosion Extent: *moderate*Erosion Conditions: *pool formation at culvert outlet, poor culvert alignment*

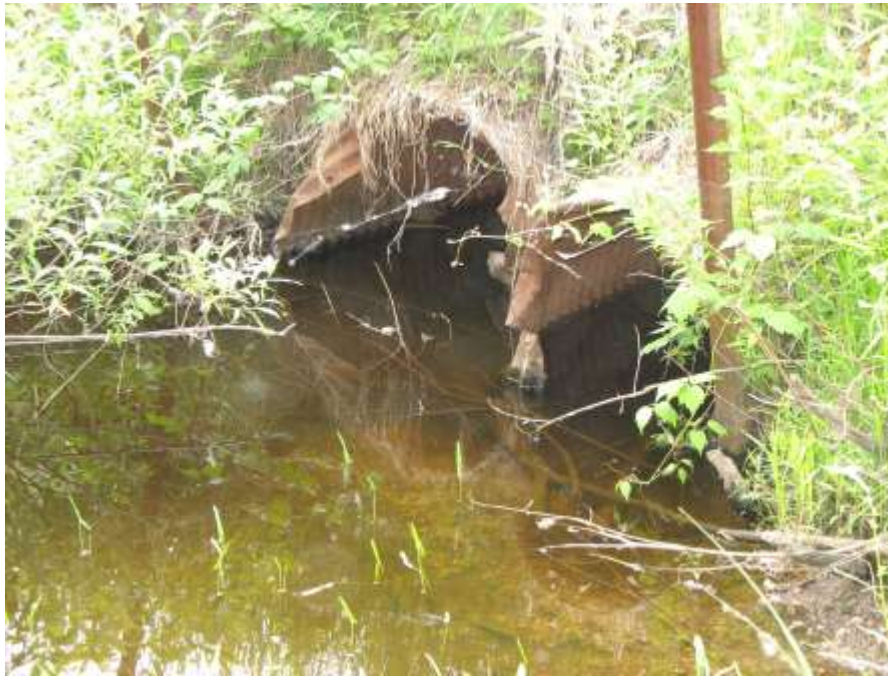
**Location**County: *Alcona*Stream Name: *Black River*Road Name: *Trask Lake Rd*Township: *Harrisville*Adjacent Landowners: *private***Culvert Description**Crossing Type: *twin culverts*Culvert Length (ft): *32*Culvert Diameter (in): *36"*Culvert Condition: *poor*Culvert Flow: *clear*Fish Passage Problem: *No*Culvert Fill Depth-inlet, outlet (ft): *4, 4*Culvert Embankment Slopes: *1:1.5, 1:1.5*Culvert Material: *galvanized***Erosion**Severity Category: *moderate*Erosion Extent: *minor*Erosion Conditions: *pool formation at culvert outlet, sand soil over crossing*
