Chapter Four: Cheboygan River/Lower Black River Nonpoint Source Inventory

Streambank Erosion Inventory

Road/Stream Crossing Inventory

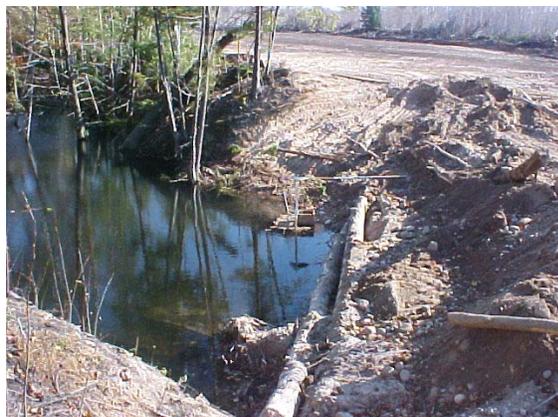
A total of nineteen sites displaying significant amounts of streambank erosion were located within the watershed. Eight of the sites show minor amounts of erosion, ten have moderate erosion, and one site was considered severe. The minor sites were located on the Cheboygan River, the Maple River, and the Lower Black River. The Cheboygan, Maple and Lower Black Rivers along with Myers Creek and Owens Creek all had sites of moderate erosion. The only site determined to be severely eroded was located on the Cheboygan River. The causes of erosion varied from site to site. A few of the erosion sites were naturally occurring from a bend in the river, wildlife access or bank seepage. The erosion at many of the sites, however, was the result of human activities. Sites where livestock had access to streams, and fishing and boat-launch sites in particular often showed moderate to severe signs of erosion. **Table 8** is a brief summary of the streambank inventory.

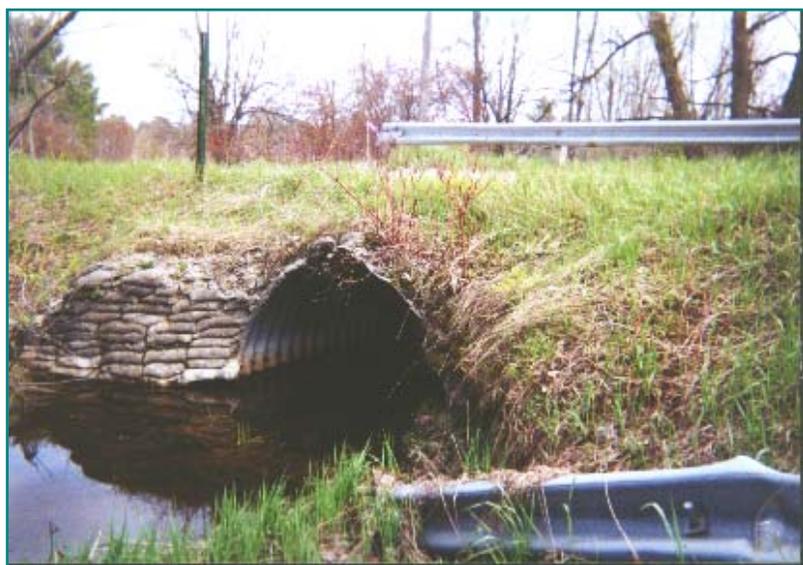
The road/ stream crossing inventory was conducted in the spring and summer months of 2002 by Northeast Michigan Council of Government (NEMCOG) staff. Using topographical and county road maps, possible road/stream crossings were located and each site was visited. At each site photographs were taken of upstream, downstream, and left and right approaches. Physical

condition and measurements of the culvert, the roadway, the length and slope of

approach, road width and surface type, stream depth and current, amounts and causes of erosion, and extent of vegetation were recorded. Using the data collected, each site was assigned a ranking of minor, moderate or severe based on the point system found on the severity ranking sheet. A site with a score between 0-15 ranks *Minor*, 16-29 is considered *Moderate*, and a score of 30 or more indicates a *Severe* site. Best Management Practices (BMPs) were determined according to the needs of each site. Sample inventory sheets and ranking sheets are included in **Appendices C** and **D**, respectively.
