Alcona Black River & Coastal Watersheds 2011 Watershed Management Plan

Northeast Michigan Council of Governments

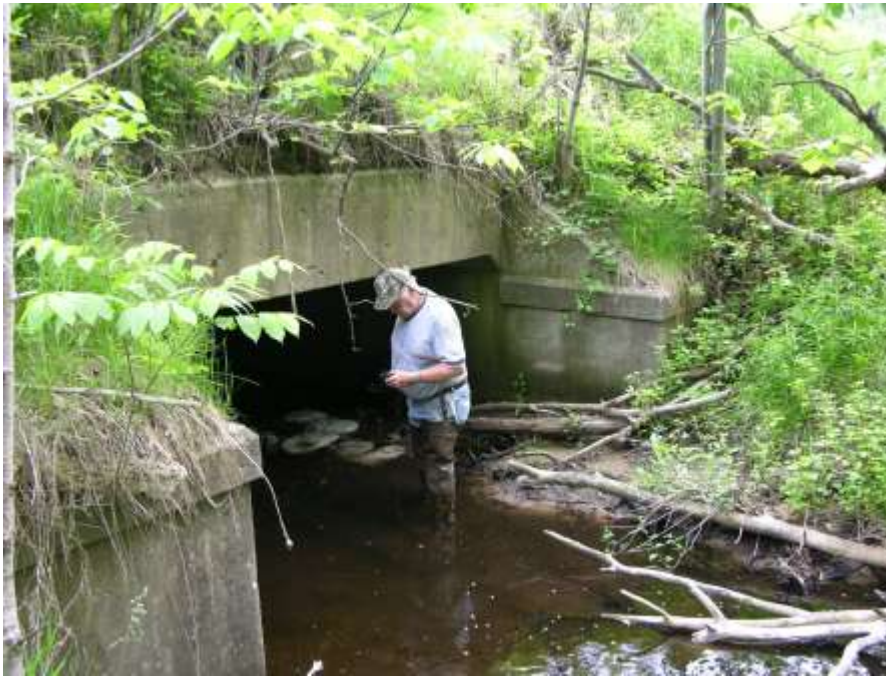
**Location**County: *Alcona*Stream Name: *Butternut Creek*Road Name: *F-41 (Barlow Rd)*Township: *Alcona*Adjacent Landowners: *private***Culvert Description**Crossing Type: *concrete box*Culvert Length (ft): *54*Culvert Diameter (in): **36"**Culvert Condition: *good*Culvert Flow: *clear*Fish Passage Problem: *No*Culvert Fill Depth-inlet, outlet (ft): *11, 11*Culvert Embankment Slopes: *1:1.5, 1:1.5*Culvert Material: *concrete***Erosion**Severity Category: *moderate*Erosion Extent: *minor*Erosion Conditions: *none***RECOMMENDED TREATMENTS:** *none***ESTIMATED COST:** *na***Road Data**Average Width at Crossing (ft): *46*Surface: *paved*Left Approach Length (ft): *400'*Right Approach Length (ft): *640'*Left Approach Slope: *1-5%*Right Approach Slope: *>10%*Ditch, Shoulder Vegetation: *heavy, heavy***Stream Characteristics**Average Upstream Width (ft): *12*Average Downstream Width (ft): *12*Average Upstream Depth (ft): *1*Average Downstream Depth (ft): *1*Upstream Current: *moderate*Downstream Current: *moderate*

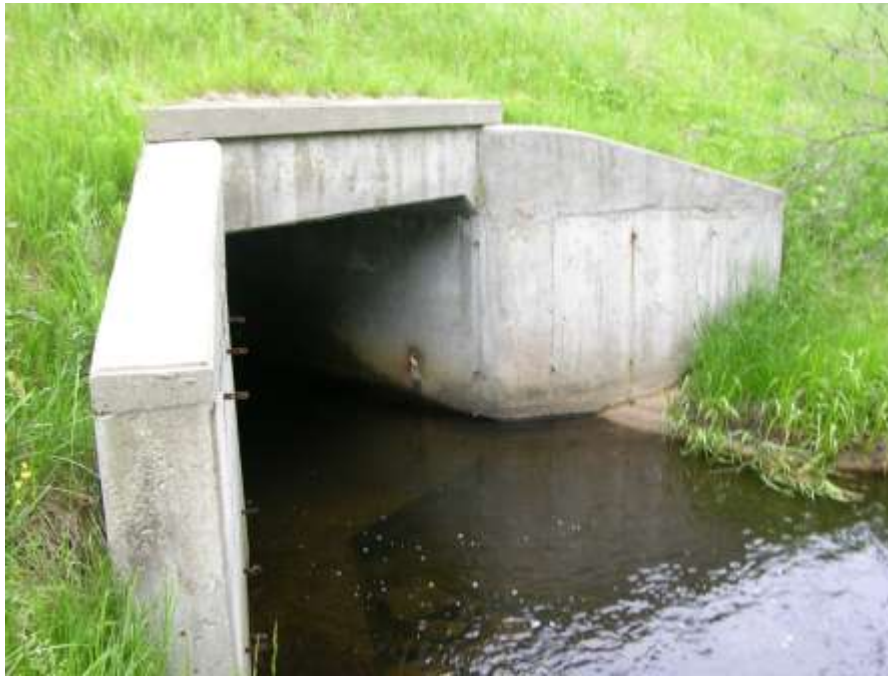
**Location**County: *Alcona*Stream Name: *Butternut Creek*Road Name: *US-23*Township: *Alcona*Adjacent Landowners: *private***Culvert Description**Crossing Type: *concrete box*Culvert Length (ft): *96*Culvert Diameter (in): *96"*Culvert Condition: *good*Culvert Flow: *clear*Fish Passage Problem: *No*Culvert Fill Depth-inlet, outlet (ft): *12, 12*Culvert Embankment Slopes: *1:1.5, 1:1.5*Culvert Material: *concrete***Erosion**Severity Category: *moderate*Erosion Extent: *minor*Erosion Conditions: *none***RECOMMENDED TREATMENTS:** *none***ESTIMATED COST:** *na***Road Data**Average Width at Crossing (ft): *60*Surface: *paved*Left Approach Length (ft): *1500*Right Approach Length (ft): *450*Left Approach Slope: *>10%*Right Approach Slope: *1-5%*Ditch, Shoulder Vegetation: *heavy, heavy***Stream Characteristics**Average Upstream Width (ft): *7*Average Downstream Width (ft): *6*Average Upstream Depth (ft): *1*Average Downstream Depth (ft): *1*Upstream Current: *moderate*Downstream Current: *moderate*

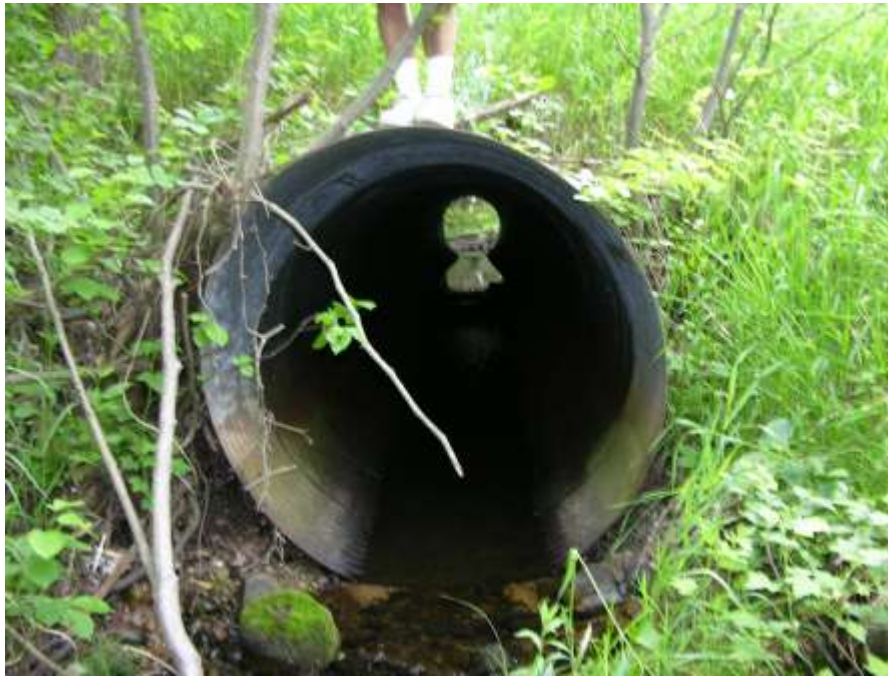
**Location**County: *Alcona*Stream Name: *Liston*Road Name: *Black River/Sayers Rd*Township: *Alcona*Adjacent Landowners: *private***Culvert Description**Crossing Type: *single culvert*Culvert Length (ft): *72*Culvert Diameter (in): *60"*Culvert Condition: *good*Culvert Flow: *clear*Fish Passage Problem: *No*Culvert Fill Depth-inlet, outlet (ft): *10, 10*Culvert Embankment Slopes: *1:1.5, 1:1.5*Culvert Material: *galvanized***Erosion**Severity Category: *moderate*Erosion Extent: *minor*Erosion Conditions: *none***RECOMMENDED TREATMENTS:** *none***ESTIMATED COST:** *na***Road Data**Average Width at Crossing (ft): *27*Surface: *paved*Left Approach Length (ft): *300*Right Approach Length (ft): *1500*Left Approach Slope: *>10%*Right Approach Slope: *6-10%*Ditch, Shoulder Vegetation: *heavy, heavy***Stream Characteristics**Average Upstream Width (ft): *4.5*Average Downstream Width (ft): *3*Average Upstream Depth (ft): *0.5*Average Downstream Depth (ft): *0.25*Upstream Current: *moderate*Downstream Current: *moderate*

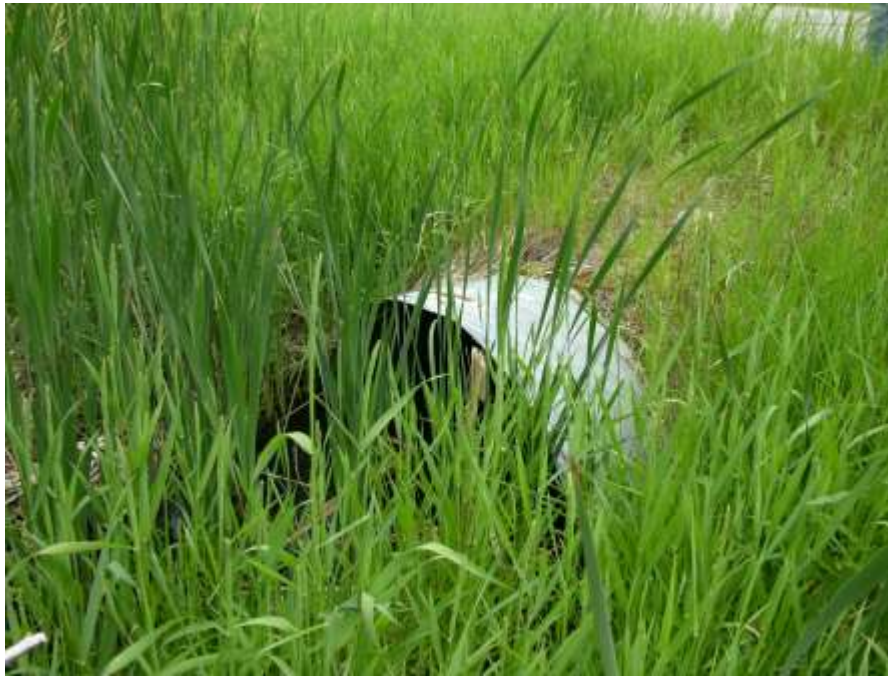
**Location**County: *Alcona*Stream Name: *DeRocher*Road Name: *Black River Rd*Township: *Alcona*Adjacent Landowners: *private***Culvert Description**Crossing Type: *single culvert*Culvert Length (ft): *48*Culvert Diameter (in): *48"*Culvert Condition: *fair*Culvert Flow: *clear*Fish Passage Problem: *No*Culvert Fill Depth-inlet, outlet (ft): *1, 1*Culvert Embankment Slopes: *1:1.5, 1:1.5*Culvert Material: *galvanized***Erosion**Severity Category: *moderate*Erosion Extent: *minor*Erosion Conditions: *none***RECOMMENDED TREATMENTS:** *none***ESTIMATED COST:** *na***Road Data**Average Width at Crossing (ft): *20*Surface: *paved*Left Approach Length (ft): *2640*Right Approach Length (ft): *0*Left Approach Slope: *6-10%*Right Approach Slope: *0*Ditch, Shoulder Vegetation: *heavy, heavy***Stream Characteristics**Average Upstream Width (ft): *0.5*Average Downstream Width (ft): *0.5*Average Upstream Depth (ft): *0.25*Average Downstream Depth (ft): *0.25*Upstream Current: *slow*Downstream Current: *slow*

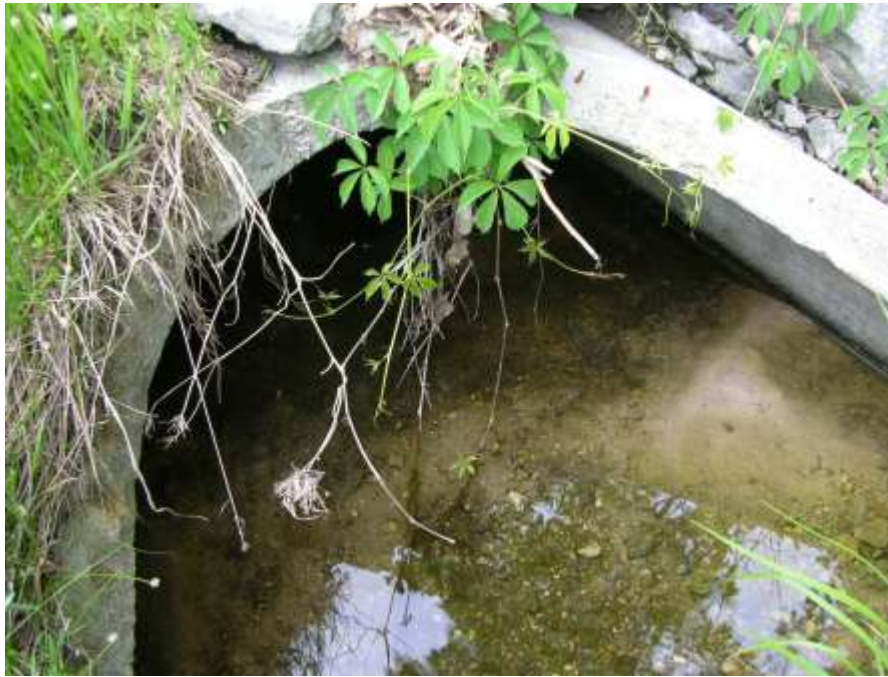
**Location**County: *Alcona*Stream Name: *DeRocher*Road Name: *US-23*Township: *Alcona*Adjacent Landowners: *private***Culvert Description**Crossing Type: *single culvert*Culvert Length (ft): *160*Culvert Diameter (in): *48"*Culvert Condition: *good*Culvert Flow: *clear*Fish Passage Problem: *No*Culvert Fill Depth-inlet, outlet (ft): *27, 27*Culvert Embankment Slopes: *>1:2, >1:2*Culvert Material: *concrete***Erosion**Severity Category: *moderate*Erosion Extent: *minor*Erosion Conditions: *none***RECOMMENDED TREATMENTS:** *none***ESTIMATED COST:** *na***Road Data**Average Width at Crossing (ft): *60*Surface: *paved*Left Approach Length (ft): *1000*Right Approach Length (ft): *1000*Left Approach Slope: *1-5%*Right Approach Slope: *6-10%*Ditch, Shoulder Vegetation: *heavy, heavy***Stream Characteristics**Average Upstream Width (ft): *1*Average Downstream Width (ft): *1*Average Upstream Depth (ft): *0.25*Average Downstream Depth (ft): *0.25*Upstream Current: *slow*Downstream Current: *moderate*

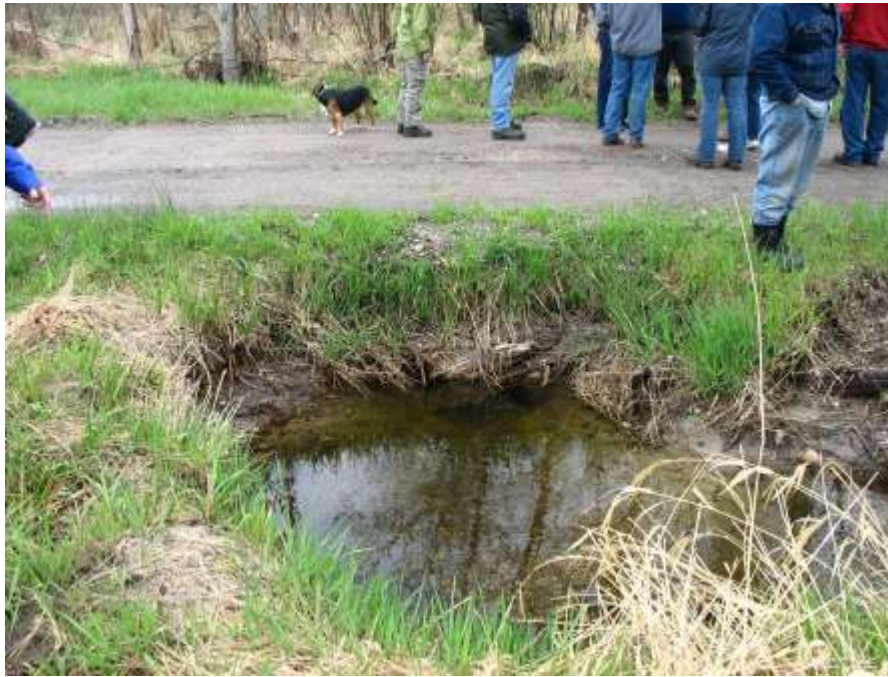
**Location**County: *Alcona*Stream Name: *DeRocher*Road Name: *LaFave Rd*Township: *Alcona*Adjacent Landowners: *private***Culvert Description**Crossing Type: *single culvert*Culvert Length (ft): *20*Culvert Diameter (in): *20"*Culvert Condition: *poor*Culvert Flow: *obstructed*Fish Passage Problem: *Yes*Culvert Fill Depth-inlet, outlet (ft): *.1, 1.3*Culvert Embankment Slopes: *vertical, vertical*Culvert Material: *galvanized***Erosion**Severity Category: *moderate*Erosion Extent: *extreme*Erosion Conditions: *damaged culvert, embankment erosion, pool formation at culvert outlet, shoulder/ditch erosion***RECOMMENDED TREATMENTS:** *replace with 6x4 box culvert, add rock rip rap, install 1 sediment basin, revegetate***ESTIMATED COST:** *\$6,460***Road Data**Average Width at Crossing (ft): *16*Surface: *gravel*Left Approach Length (ft): *0*Right Approach Length (ft): *0*Left Approach Slope: *0*Right Approach Slope: *0*Ditch, Shoulder Vegetation: *heavy, heavy***Stream Characteristics**Average Upstream Width (ft): *2*Average Downstream Width (ft): *0.1*Average Upstream Depth (ft): *0.5*Average Downstream Depth (ft): *0.5*Upstream Current: *moderate*Downstream Current: *moderate*

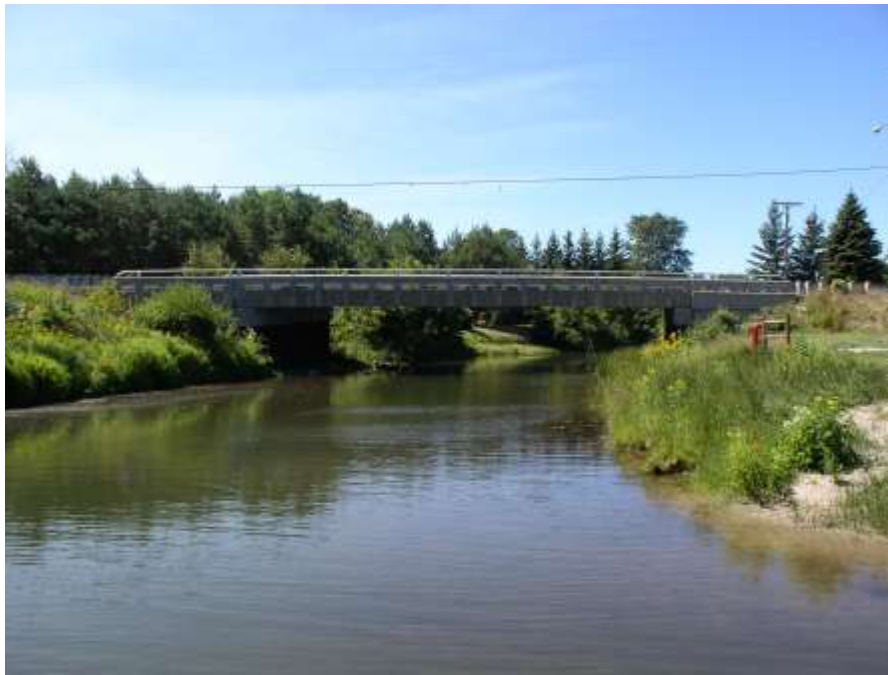
**Location**County: *Alcona*Stream Name: *Black River*Road Name: *Lakeshore Dr*Township: *Alcona*Adjacent Landowners: *local government***Culvert Description**Crossing Type: *bridge*Culvert Length (ft): *122*Culvert Diameter (in): *1,200"*Culvert Condition: *good*Culvert Flow: *clear*Fish Passage Problem: *no*Culvert Fill Depth-inlet, outlet (ft): *na, na*Culvert Embankment Slopes: *na, na*Culvert Material: *concrete***Erosion**Severity Category: *minor*Erosion Extent: *minor*Erosion Conditions: *none***RECOMMENDED TREATMENTS:** *none***ESTIMATED COST:** *na***Road Data**Average Width at Crossing (ft): *35*Surface: *paved*Left Approach Length (ft): *0*Right Approach Length (ft): *0*Left Approach Slope: *0*Right Approach Slope: *0%*Ditch, Shoulder Vegetation: *partial, partial***Stream Characteristics**Average Upstream Width (ft): *20*Average Downstream Width (ft): *25*Average Upstream Depth (ft): *3*Average Downstream Depth (ft): *5*Upstream Current: *slow*Downstream Current: *slow*

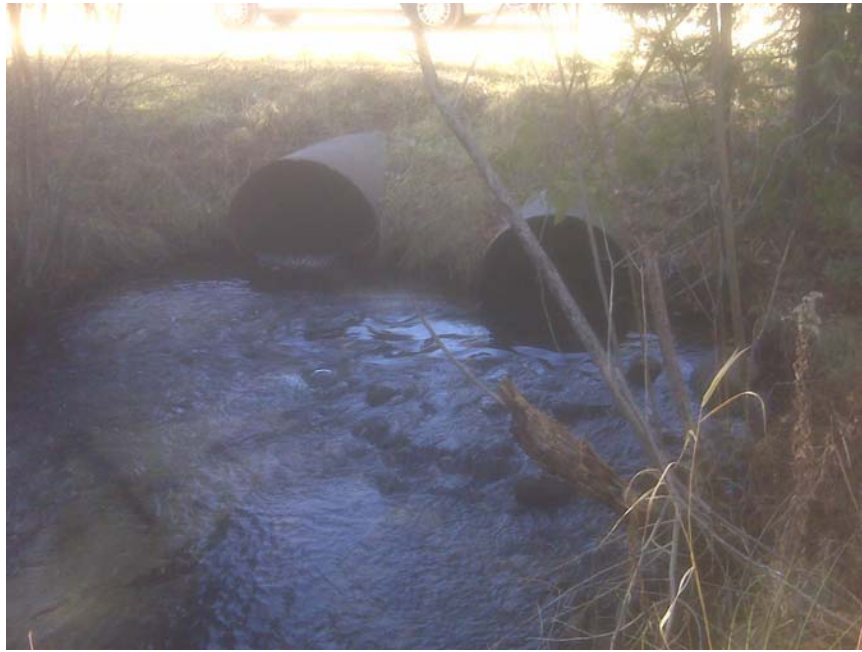
County: *Alcona*
 Stream Name: *Mill Creek*
 Road Name: *Mill Creek Rd*
 Township: *Harrisville (City)*
 Adjacent Landowners: *private*

Crossing Type: *twin culvert*
 Culvert Length (ft): *44, 46*
 Culvert Diameter (in): *42, 36*
 Culvert Condition: *poor*
 Culvert Flow: *clear*
 Fish Passage Problem: *no*
 Culvert Fill Depth-inlet, outlet (ft): *1, 1*
 Culvert Embankment Slopes: *1:1, 2:1*
 Culvert Material: *galvanized*

Severity Category: *minor*
 Erosion Extent: *minor*
 Erosion Conditions: *sand over crossing, embankment erosion*

RECOMMENDED TREATMENTS: *replace culverts with elliptical culvert, harden approaches, add rock rip rap, revegetate*

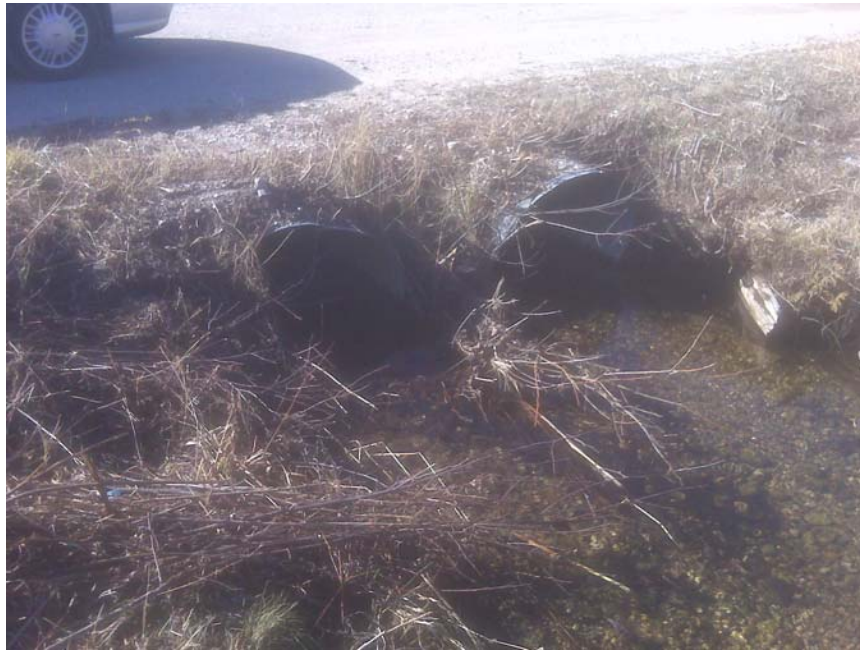
County: *Alcona*
 Stream Name: *Mill Creek*
 Road Name: *Swamp Rd*
 Township: *Harrisville*
 Adjacent Landowners: *private*

Crossing Type: *twin culvert*
 Culvert Length (ft): *28*
 Culvert Diameter (in): *36*
 Culvert Condition: *poor*
 Culvert Flow: *clear*
 Fish Passage Problem: *no*
 Culvert Fill Depth-inlet, outlet (ft): *.5, .5*
 Culvert Embankment Slopes: *vertical*
 Culvert Material: *galvanized*

Severity Category: *minor*
 Erosion Extent: *minor*
 Erosion Conditions: *sand on crossing, embankment erosion, culverts too short*

RECOMMENDED TREATMENTS: *replace culverts wit elliptical culvert, harden approaches, add rock rip rap, revegetate*

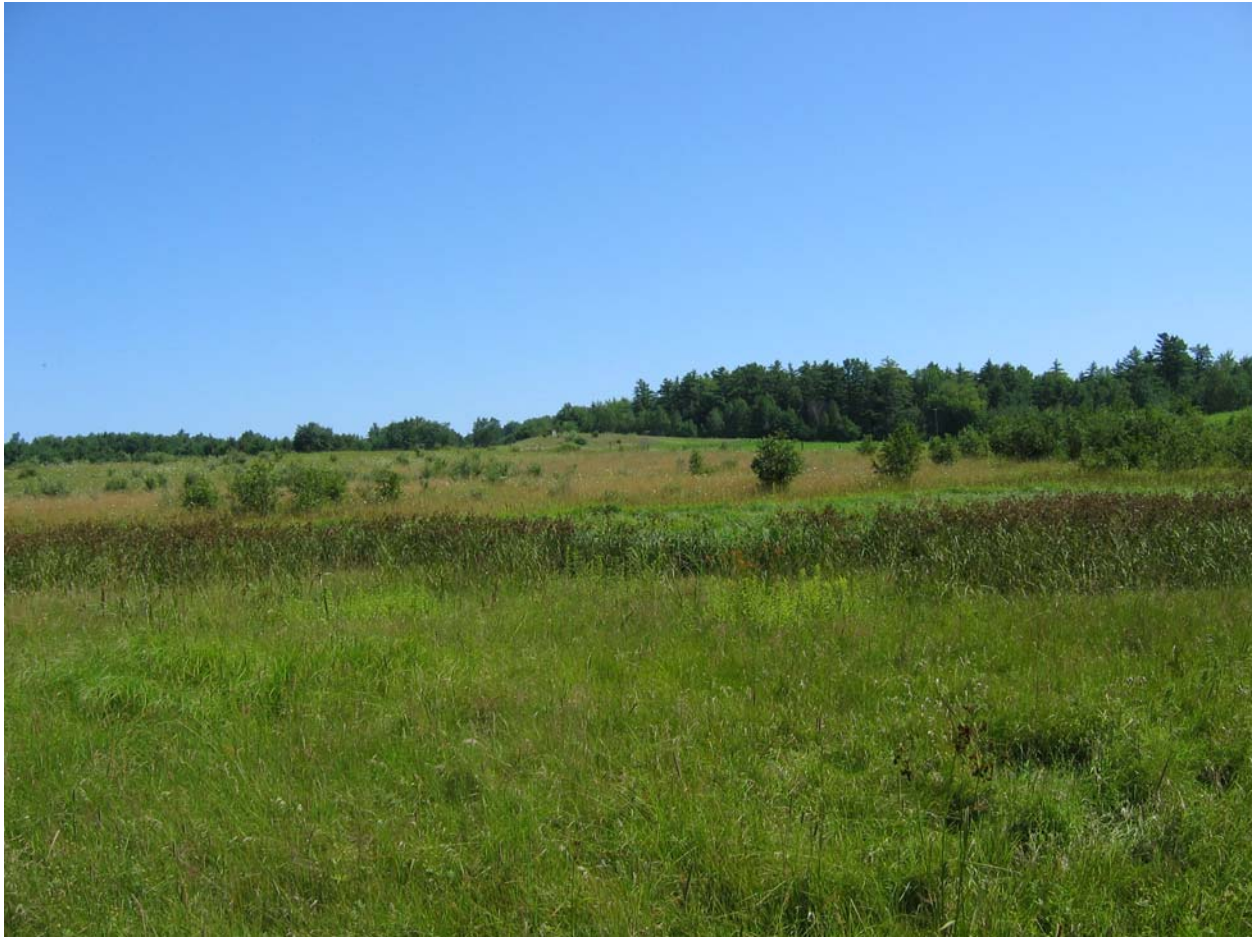
Site ID	Ag 01	Date	8/12/2009
Location		Farm Information	
Waterbody:	South Branch Black River	Type of Operation:	Crops (appears inactive)
County:	Alcona	Riparian Frontage (ft):	1000
Township:	Haynes	Distance to Water (ft):	400
Town/Range:	27N / 9E	Soil Type:	Sand
Section(s):	10	Contamination Risks:	None
Natural Resource Concern(s)		Recommended Treatments(s)	
None		None	
Severity	Minor	Cost	NA

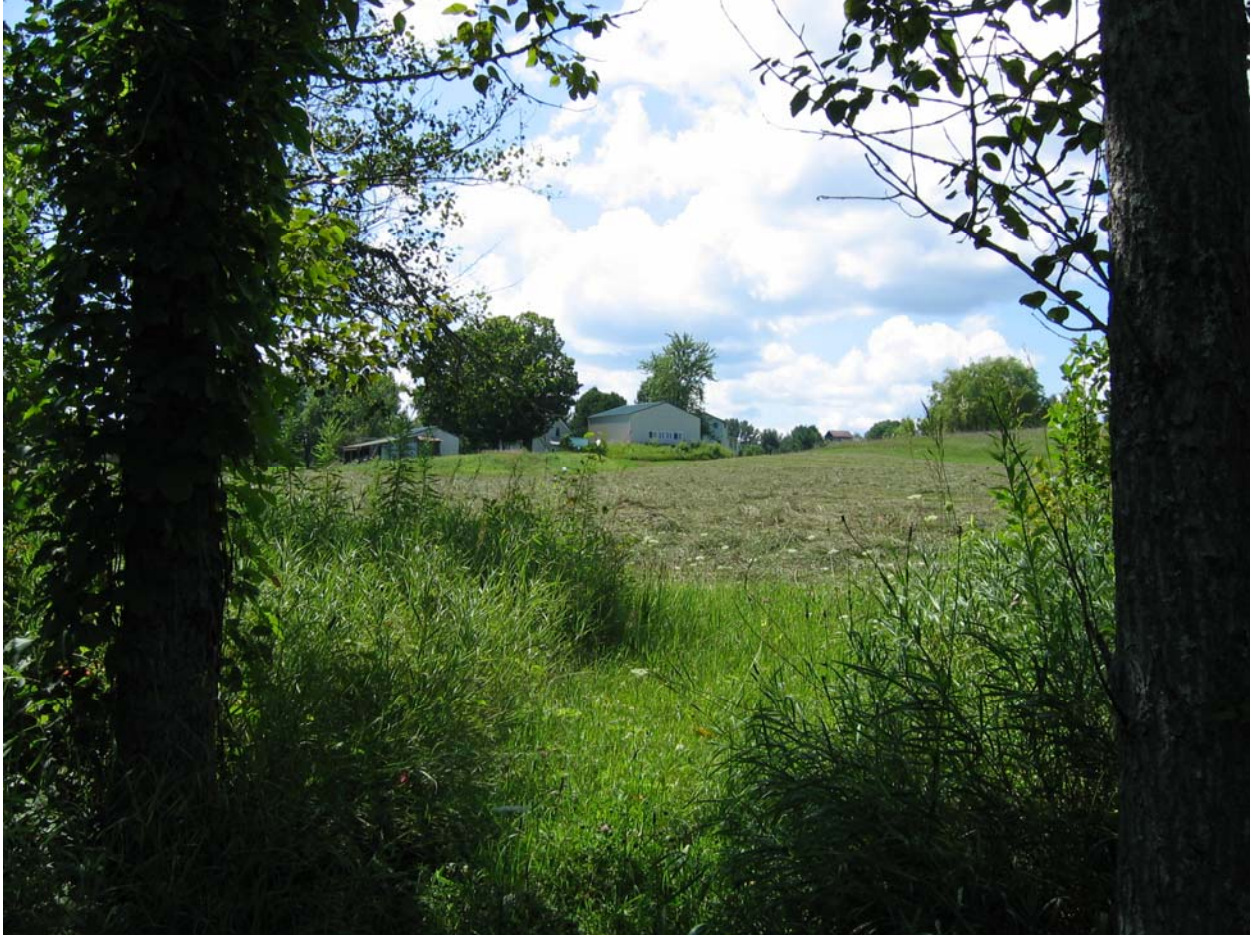
Site ID	Ag 02	Date	8/12/2009
Location		Farm Information	
Waterbody:	South Branch Black River	Type of Operation:	Crops
County:	Alcona	Riparian Frontage (ft):	3200
Township:	Haynes	Distance to Water (ft):	60
Town/Range:	27N / 9E	Soil Type:	Sand, Loam
Section(s):	10	Contamination Risks:	None
Natural Resource Concern(s)		Recommended Treatments(s)	
None		None	
Severity	Minor	Cost	NA

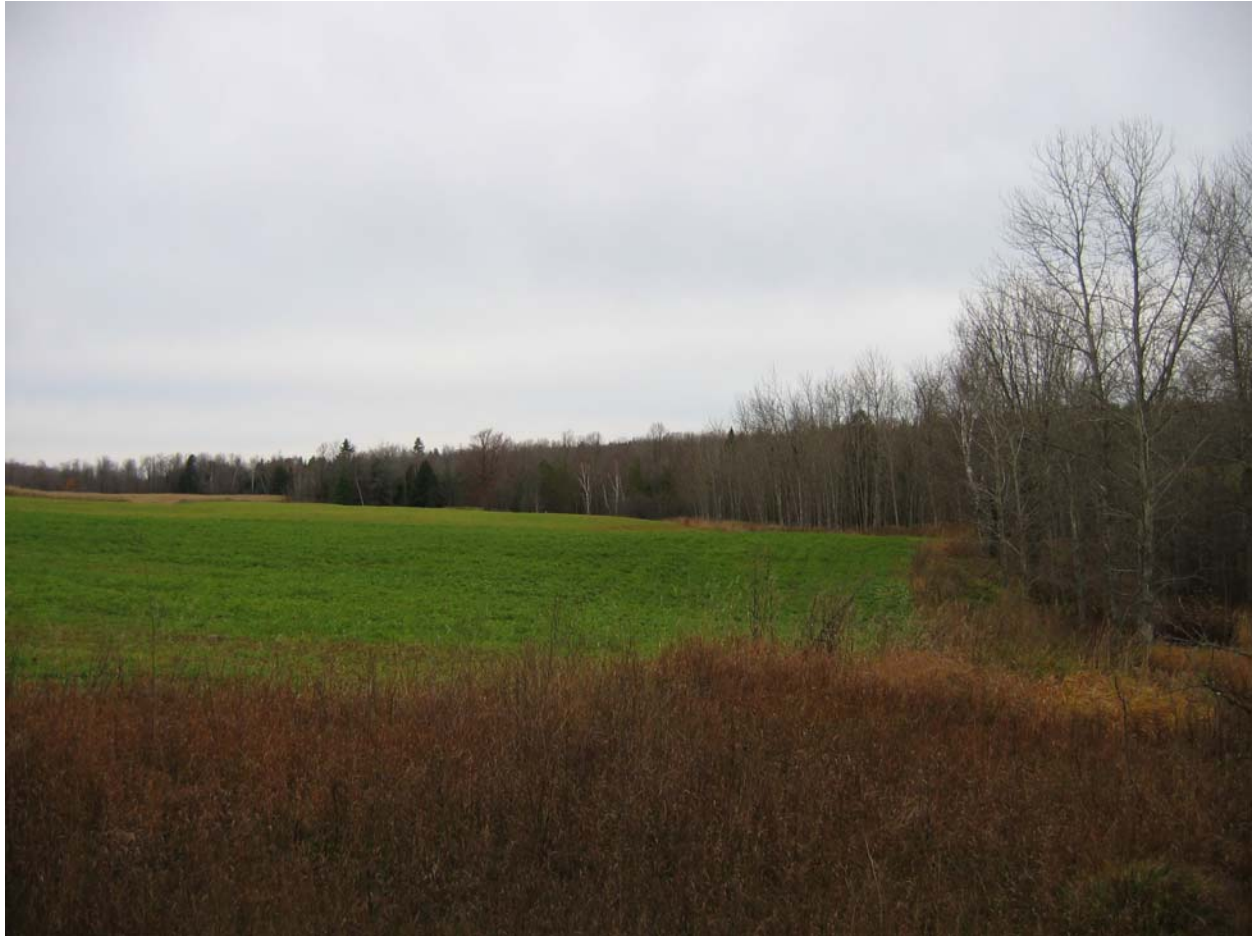
Site ID	Ag 03	Date	11/4/2009
Location		Farm Information	
Waterbody:	Liston Creek	Type of Operation:	Crops
County:	Alcona	Riparian Frontage (ft):	2600
Township:	Alcona	Distance to Water (ft):	50
Town/Range:	28N / 9E	Soil Type:	Clay, Loam
Section(s):	18	Contamination Risks:	None
Natural Resource Concern(s)		Recommended Treatments(s)	
None		None	
Severity	Minor	Cost	NA

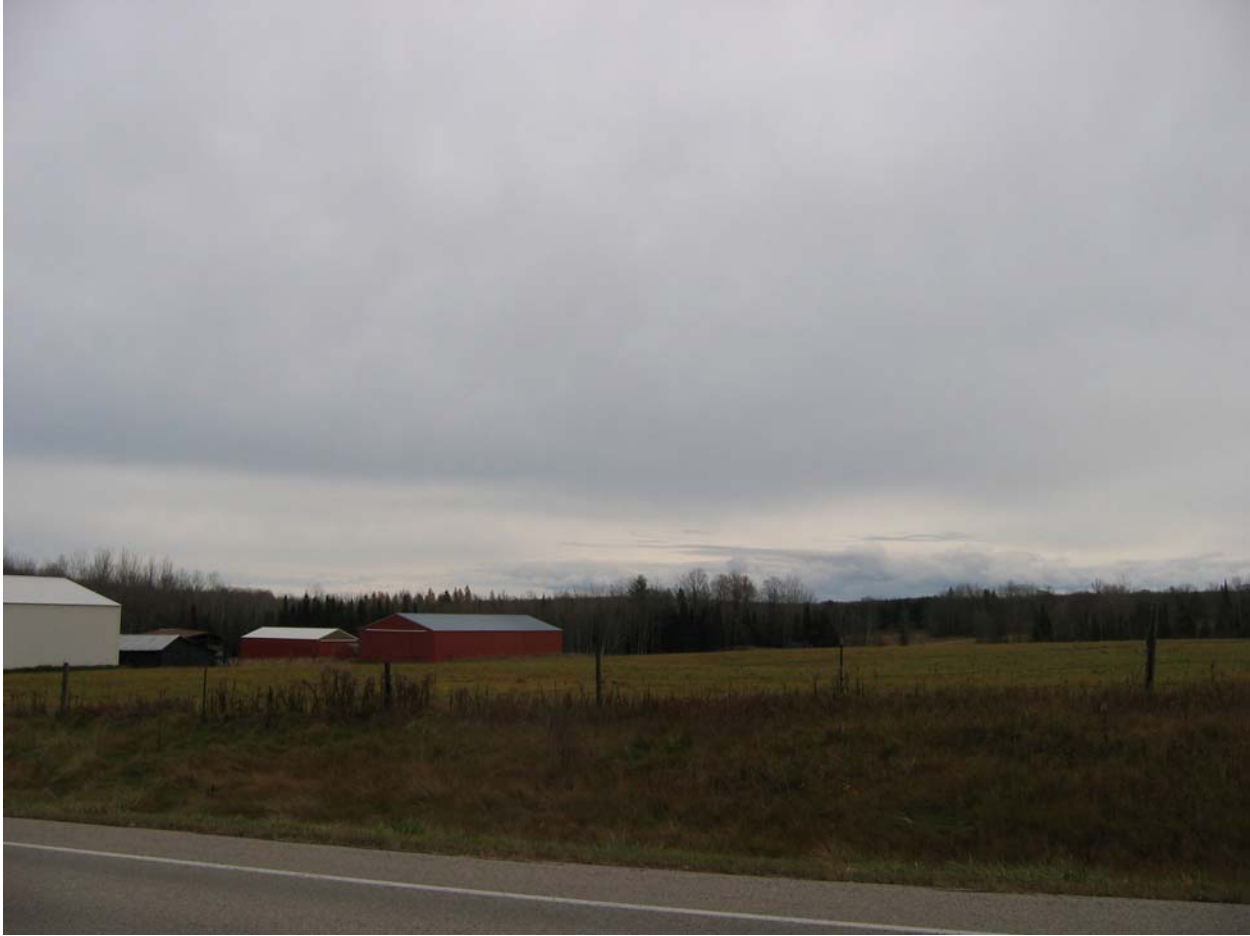
Site ID	Ag 04	Date	11/4/2009
Location		Farm Information	
Waterbody:	Butternut Creek	Type of Operation:	Crops, Livestock
County:	Alcona	Riparian Frontage (ft):	3000
Township:	Alcona	Distance to Water (ft):	100
Town/Range:	28N / 9E	Soil Type:	Clay, Loam
Section(s):	18	Contamination Risks:	None
Natural Resource Concern(s)		Recommended Treatments(s)	
None		None	
Severity	Minor	Cost	NA

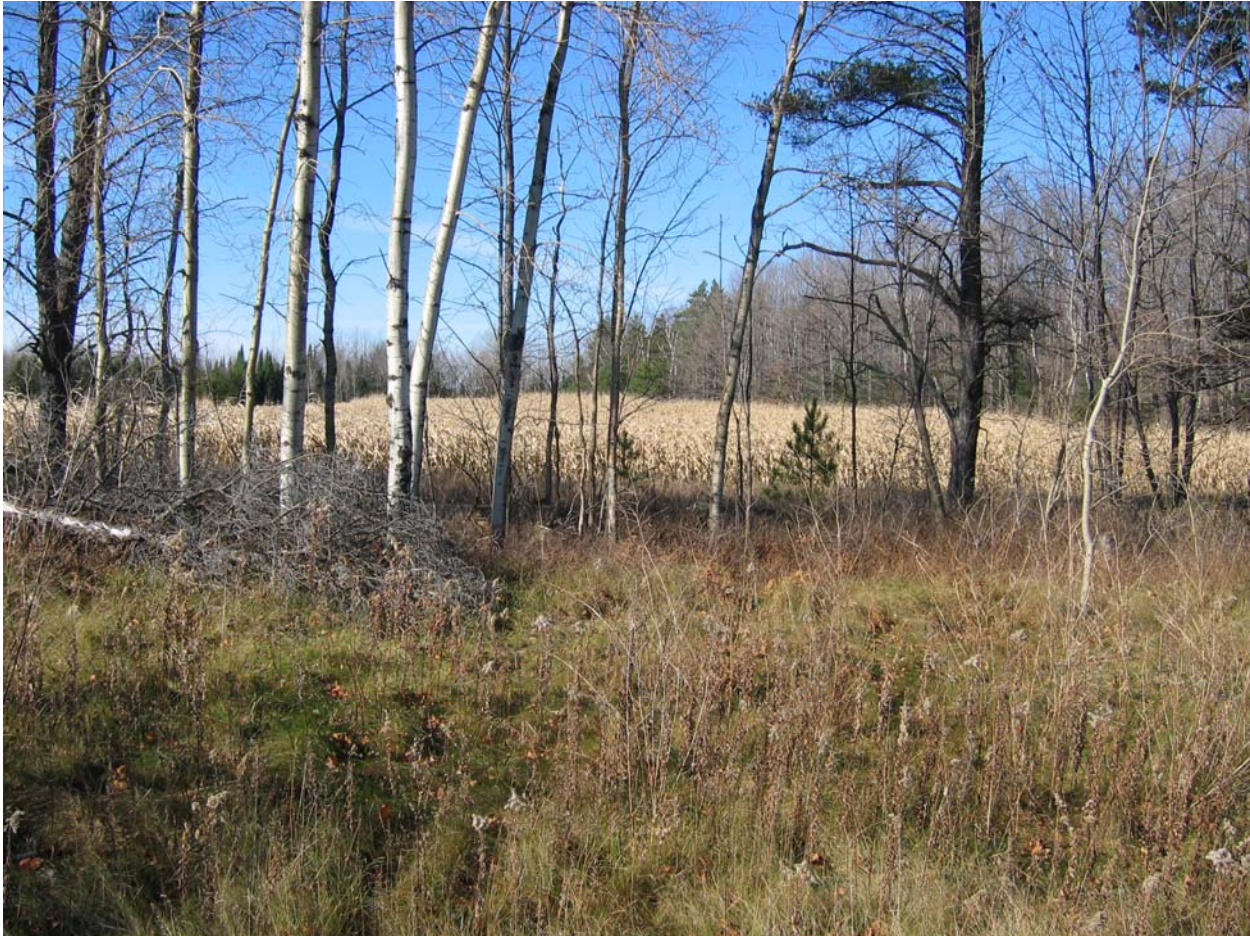
Site ID	Ag 05	Date	11/4/2009
Location		Farm Information	
Waterbody:	Butternut Creek	Type of Operation:	Crops
County:	Alcona	Riparian Frontage (ft):	600
Township:	Caledonia	Distance to Water (ft):	100
Town/Range:	28N / 8E	Soil Type:	Loam
Section(s):	13	Contamination Risks:	None
Natural Resource Concern(s)		Recommended Treatments(s)	
None		None	
Severity	Minor	Cost	NA

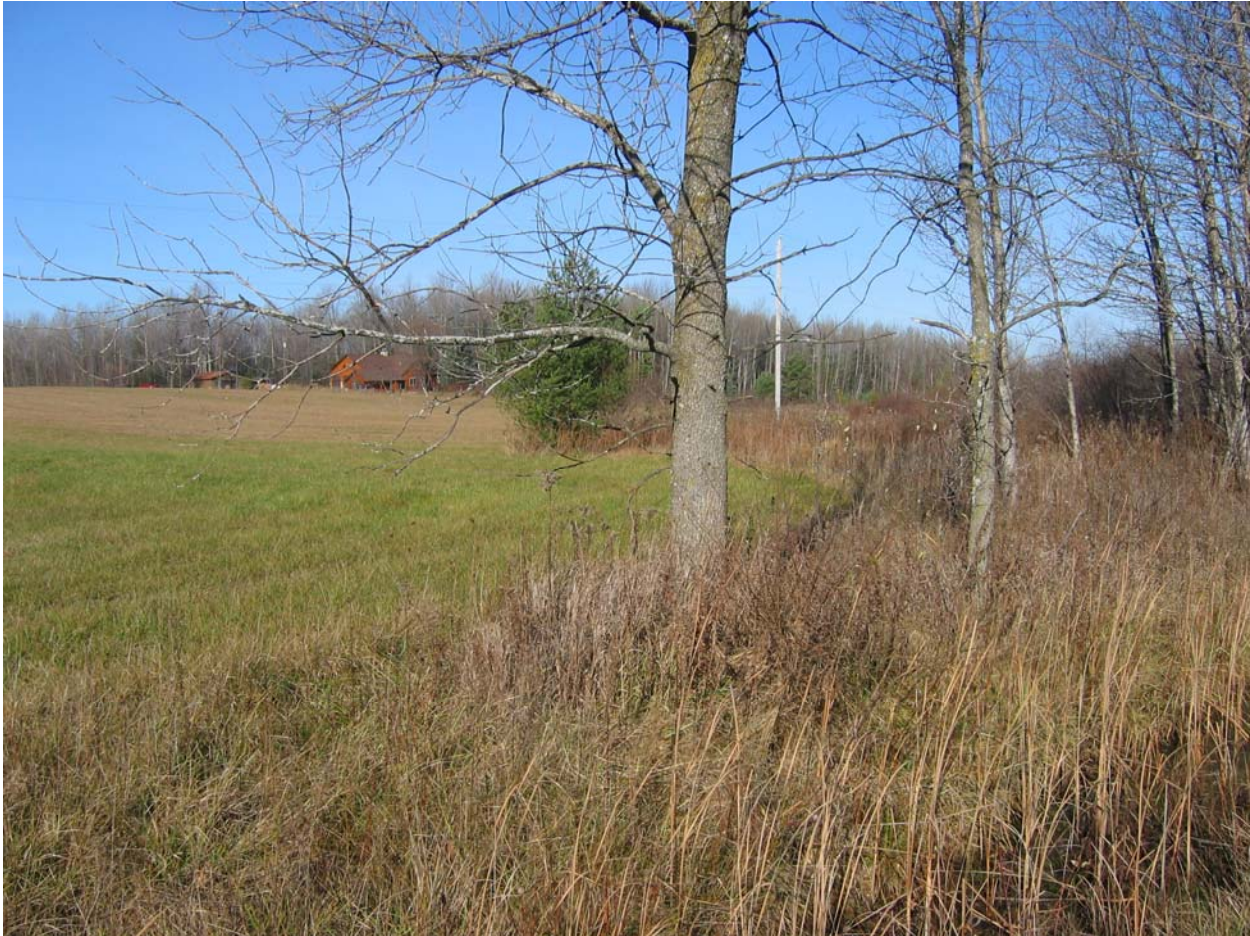
Site ID	Ag 06	Date	11/4/2009
Location		Farm Information	
Waterbody:	Butternut Creek Tributary	Type of Operation:	Crops
County:	Alcona	Riparian Frontage (ft):	600
Township:	Caledonia	Distance to Water (ft):	50
Town/Range:	28N / 8E	Soil Type:	Loam
Section(s):	10	Contamination Risks:	None
Natural Resource Concern(s)		Recommended Treatments(s)	
None		None	
Severity	Minor	Cost	NA

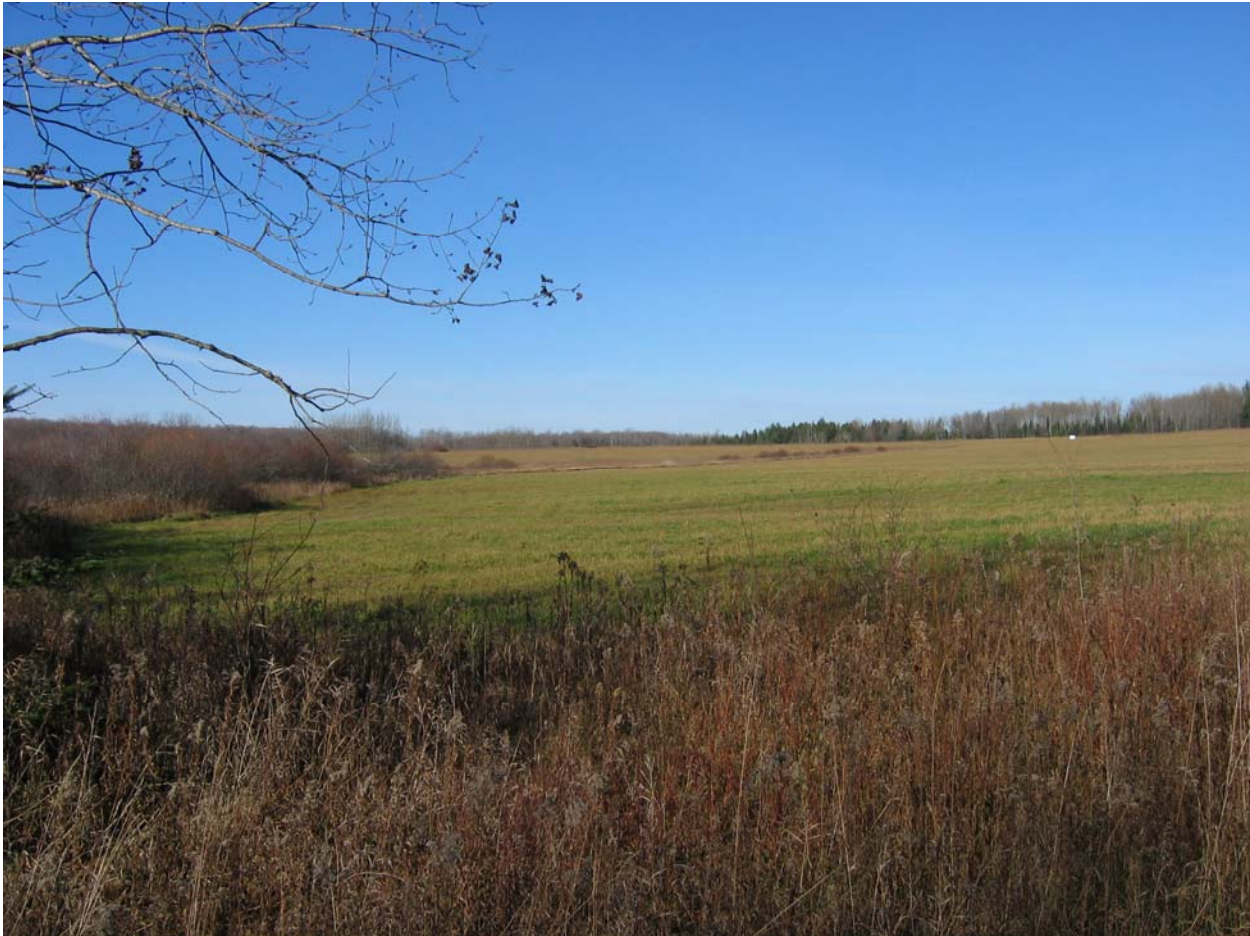
Site ID	Ag 07 & 08	Date	11/4/2009
Location		Farm Information	
Waterbody:	Butternut Creek Tributary	Type of Operation:	Crops
County:	Alcona	Riparian Frontage (ft):	5000
Township:	Caledonia	Distance to Water (ft):	50
Town/Range:	28N / 8E	Soil Type:	Loam
Section(s):	11	Contamination Risks:	None
Natural Resource Concern(s)		Recommended Treatments(s)	
None		None	
Severity	Minor	Cost	NA

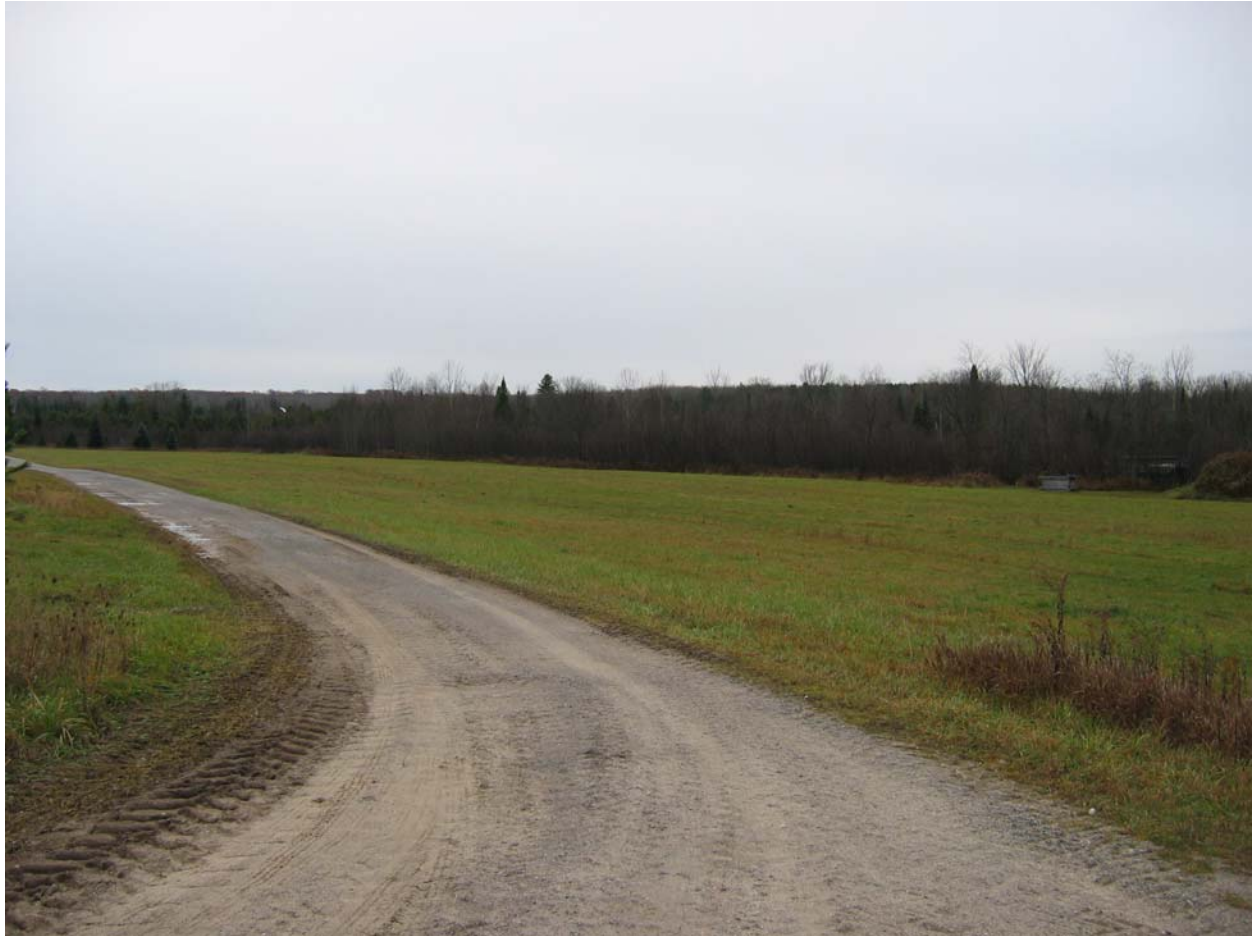
Site ID	Ag 09	Date	11/4/2009
Location		Farm Information	
Waterbody:	Butternut Creek	Type of Operation:	Crops
County:	Alcona	Riparian Frontage (ft):	1600
Township:	Caledonia	Distance to Water (ft):	75
Town/Range:	28N / 8E	Soil Type:	Loam
Section(s):	13	Contamination Risks:	None
Natural Resource Concern(s)		Recommended Treatments(s)	
None		None	
Severity	Minor	Cost	NA

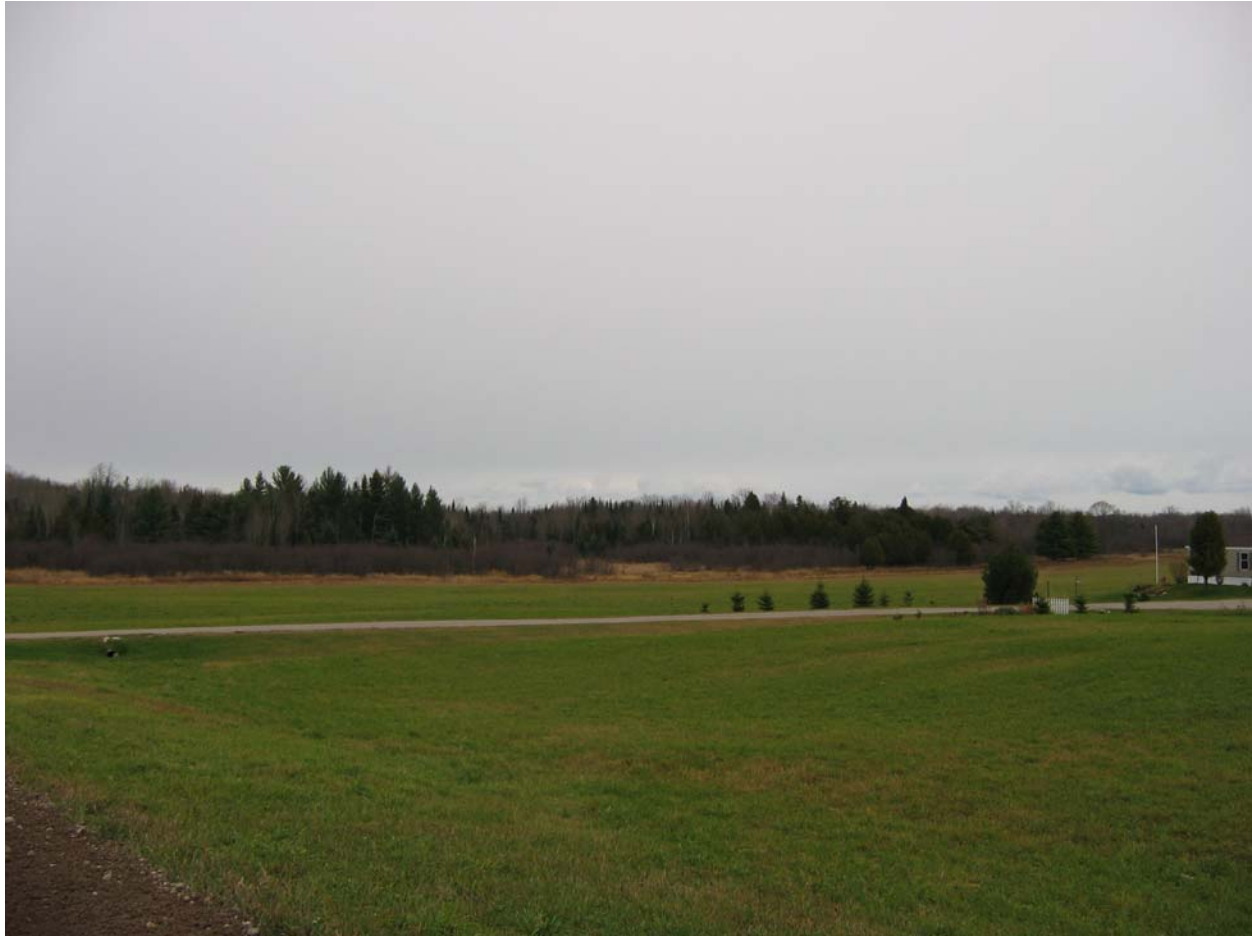
Site ID	Ag 11	Date	11/4/2009
Location		Farm Information	
Waterbody:	South Branch Black River	Type of Operation:	Livestock, Crops
County:	Alcona	Riparian Frontage (ft):	5000
Township:	Harrisville	Distance to Water (ft):	50
Town/Range:	26N / 9E	Soil Type:	Loam
Section(s):	4	Contamination Risks:	None
Natural Resource Concern(s)		Recommended Treatments(s)	
None		None	
Severity	Minor	Cost	NA

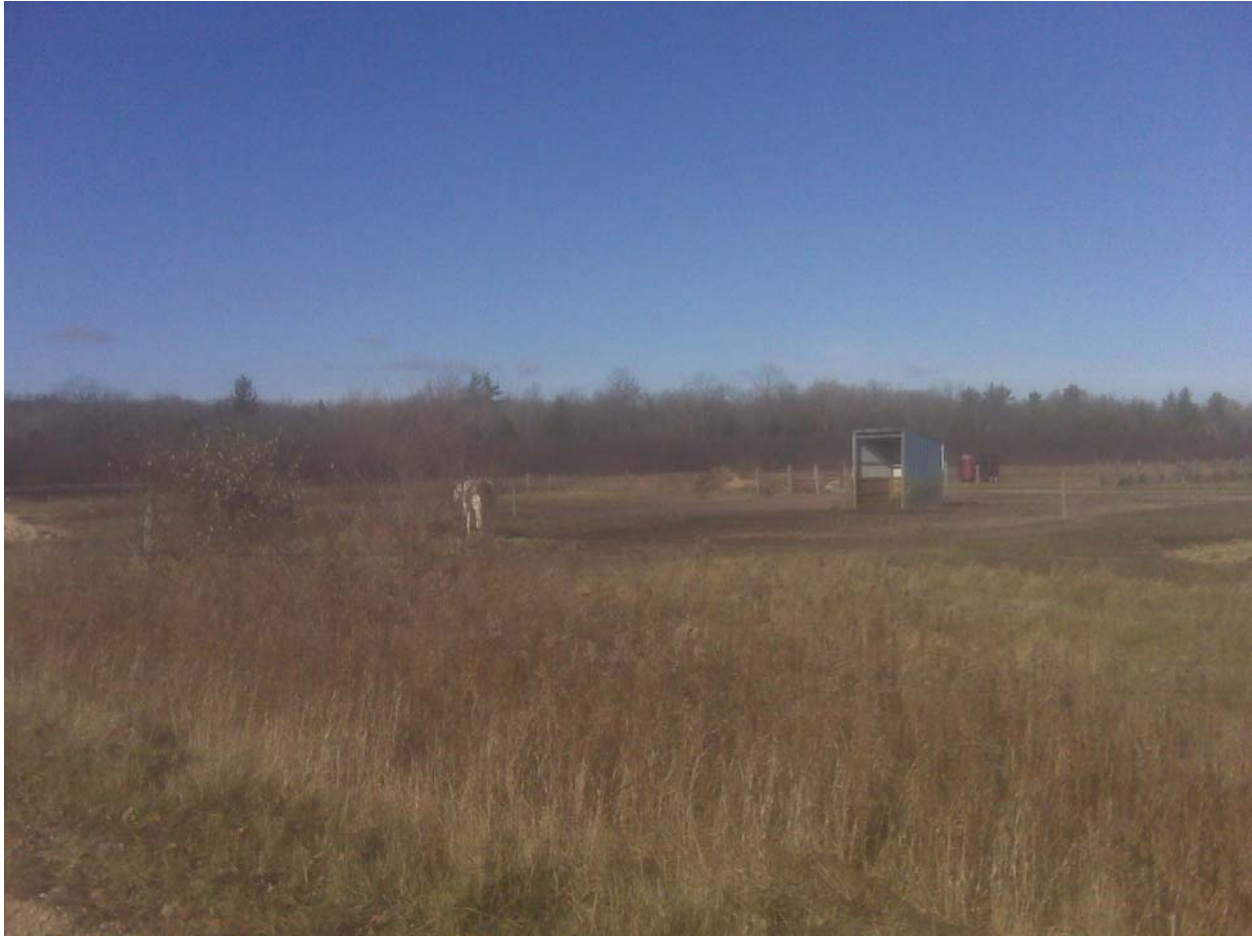
Site ID	Ag 12	Date	11/4/2009
Location		Farm Information	
Waterbody:	South Branch Black River	Type of Operation:	Livestock, Crops
County:	Alcona	Riparian Frontage (ft):	2500
Township:	Haynes	Distance to Water (ft):	75
Town/Range:	27N / 9E	Soil Type:	Loam
Section(s):	33	Contamination Risks:	None
Natural Resource Concern(s)		Recommended Treatments(s)	
None		None	
Severity	Minor	Cost	NA

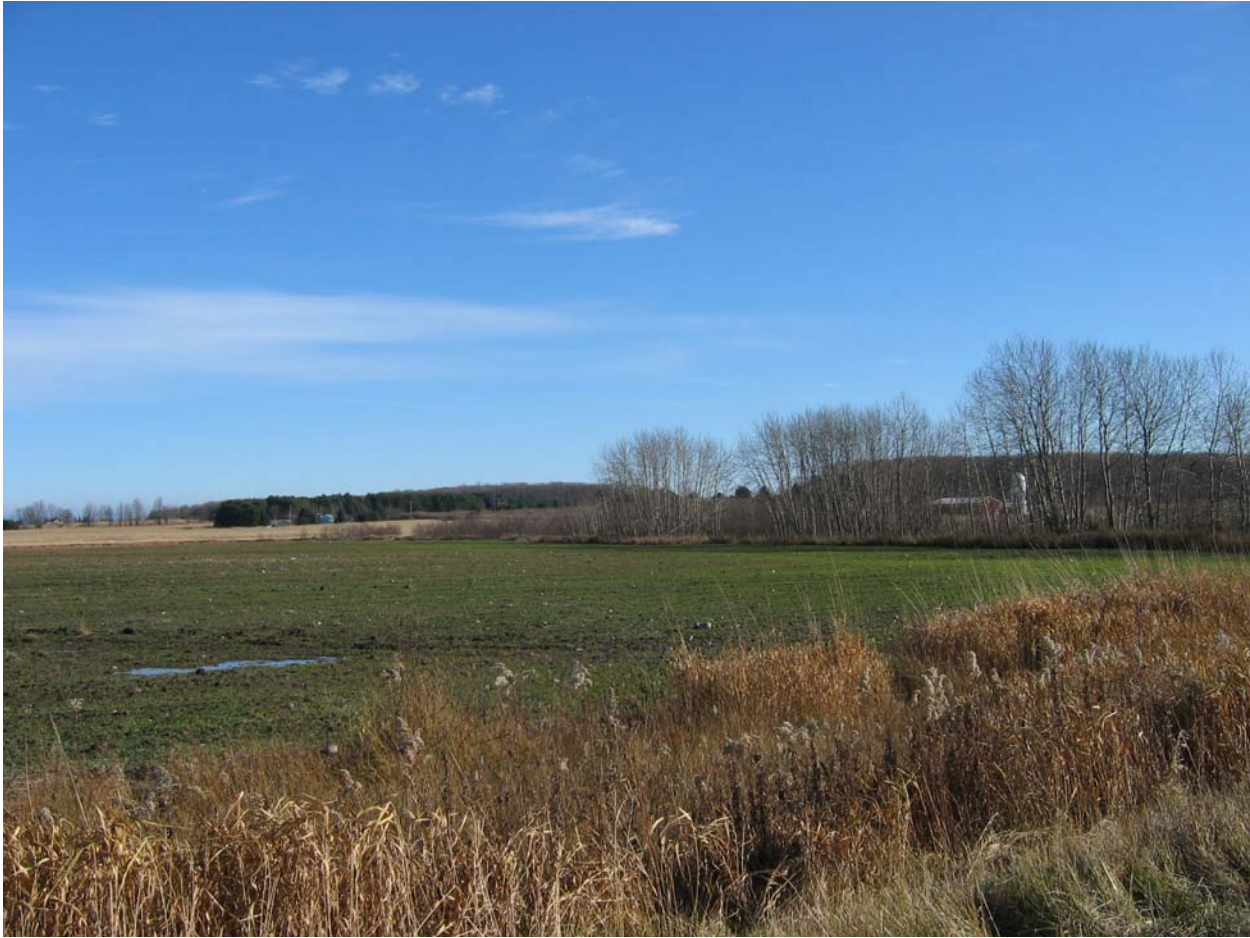
Site ID	Ag 13	Date	11/4/2009
Location		Farm Information	
Waterbody:	Haynes Creek	Type of Operation:	Crops
County:	Alcona	Riparian Frontage (ft):	2600
Township:	Haynes	Distance to Water (ft):	50
Town/Range:	27N / 9E	Soil Type:	Loam
Section(s):	20	Contamination Risks:	None
Natural Resource Concern(s)		Recommended Treatments(s)	
None		None	
Severity	Minor	Cost	NA
