Alcona Black River & Coastal Watersheds 2011 Watershed Management Plan

Northeast Michigan Council of Governments

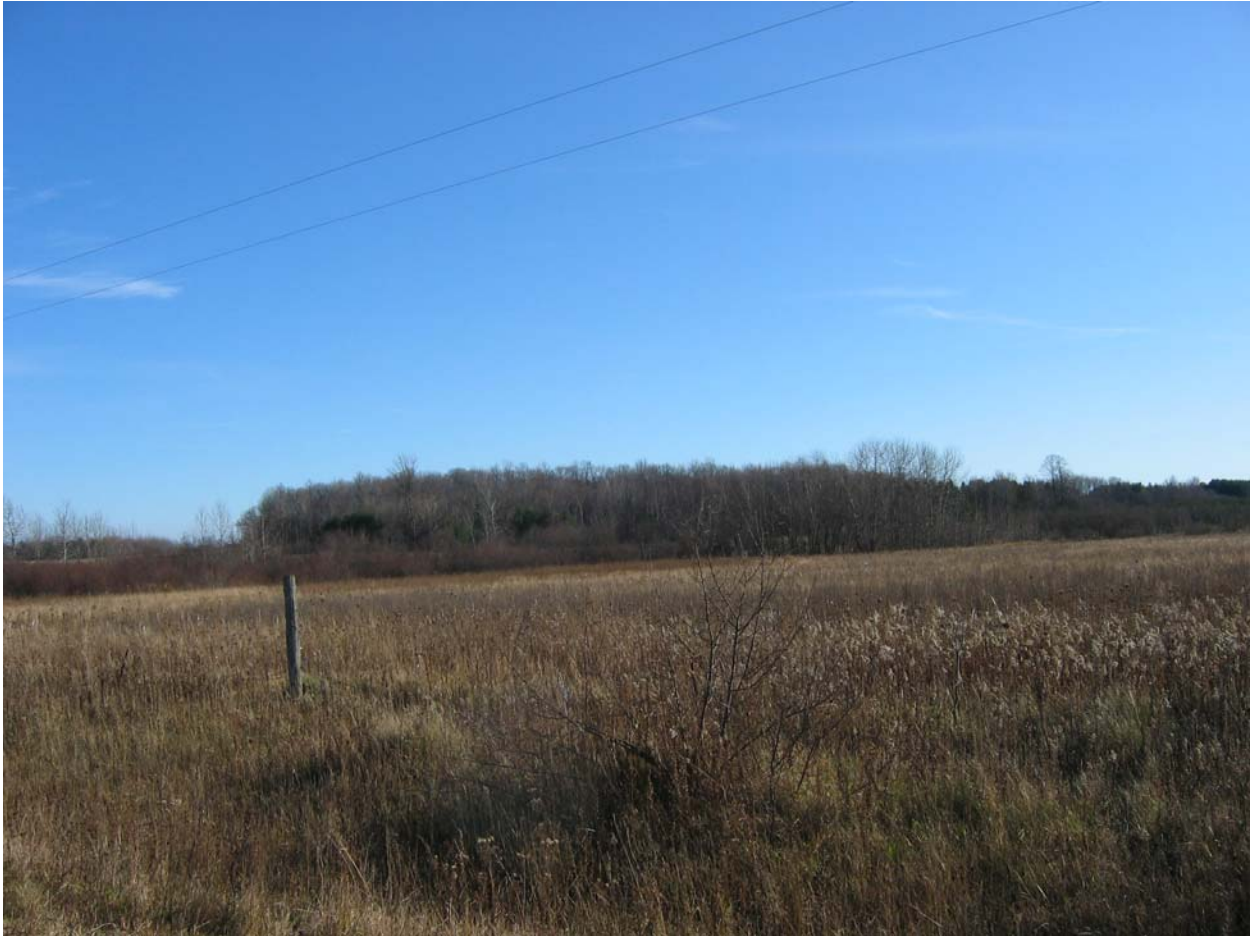
Site ID	Ag 14	Date	11/4/2009
Location		Farm Information	
Waterbody:	Haynes Creek	Type of Operation:	Crops
County:	Alcona	Riparian Frontage (ft):	3000
Township:	Haynes	Distance to Water (ft):	50
Town/Range:	27N / 9E	Soil Type:	Loam
Section(s):	20	Contamination Risks:	None
Natural Resource Concern(s)		Recommended Treatments(s)	
None		None	
Severity	Minor	Cost	NA

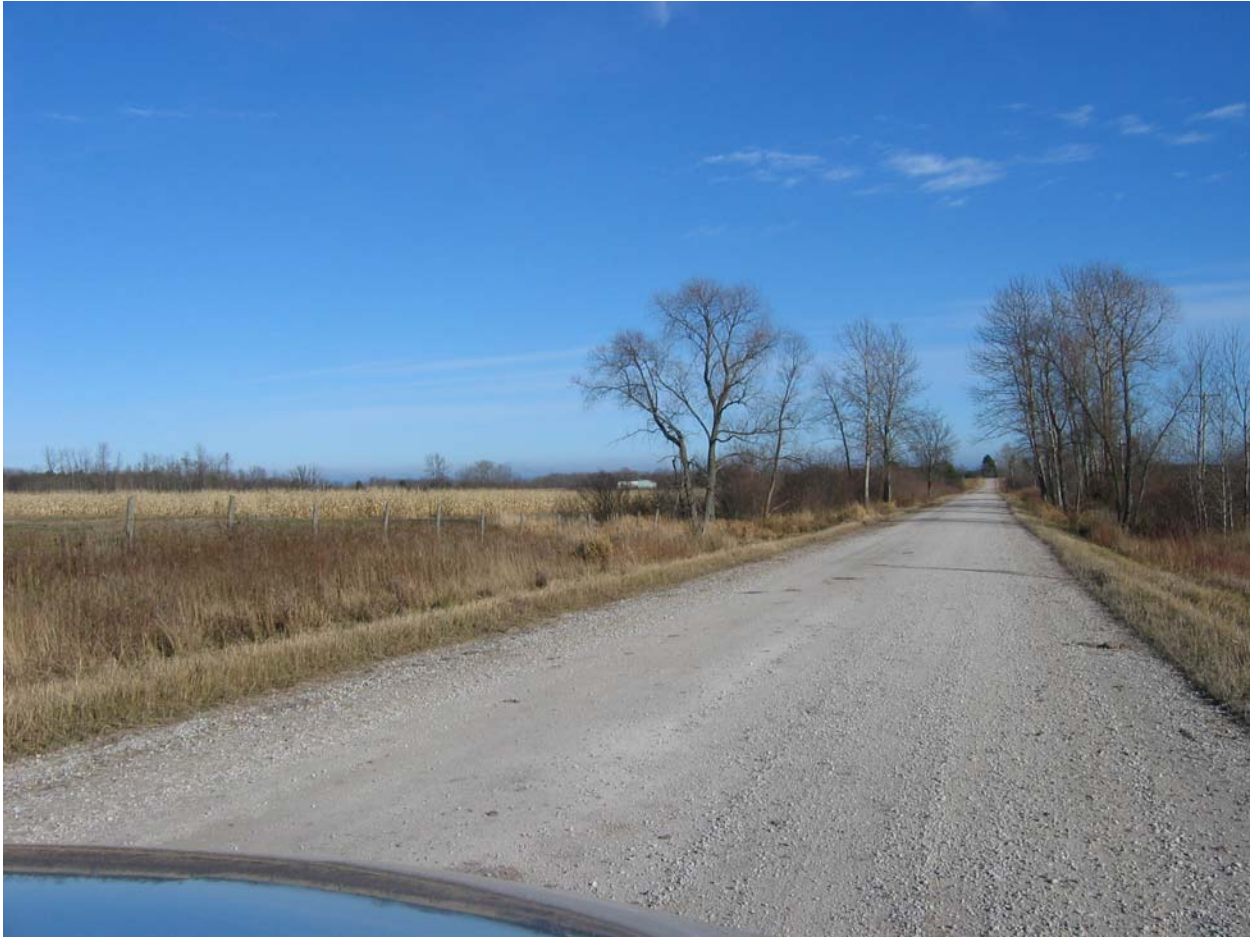
Site ID	Ag 15	Date	11/4/2009
Location		Farm Information	
Waterbody:	Haynes Creek	Type of Operation:	Crops
County:	Alcona	Riparian Frontage (ft):	3000
Township:	Haynes	Distance to Water (ft):	25
Town/Range:	27N / 9E	Soil Type:	Loam
Section(s):	17	Contamination Risks:	None
Natural Resource Concern(s)		Recommended Treatments(s)	
None		None	
Severity	Minor	Cost	NA

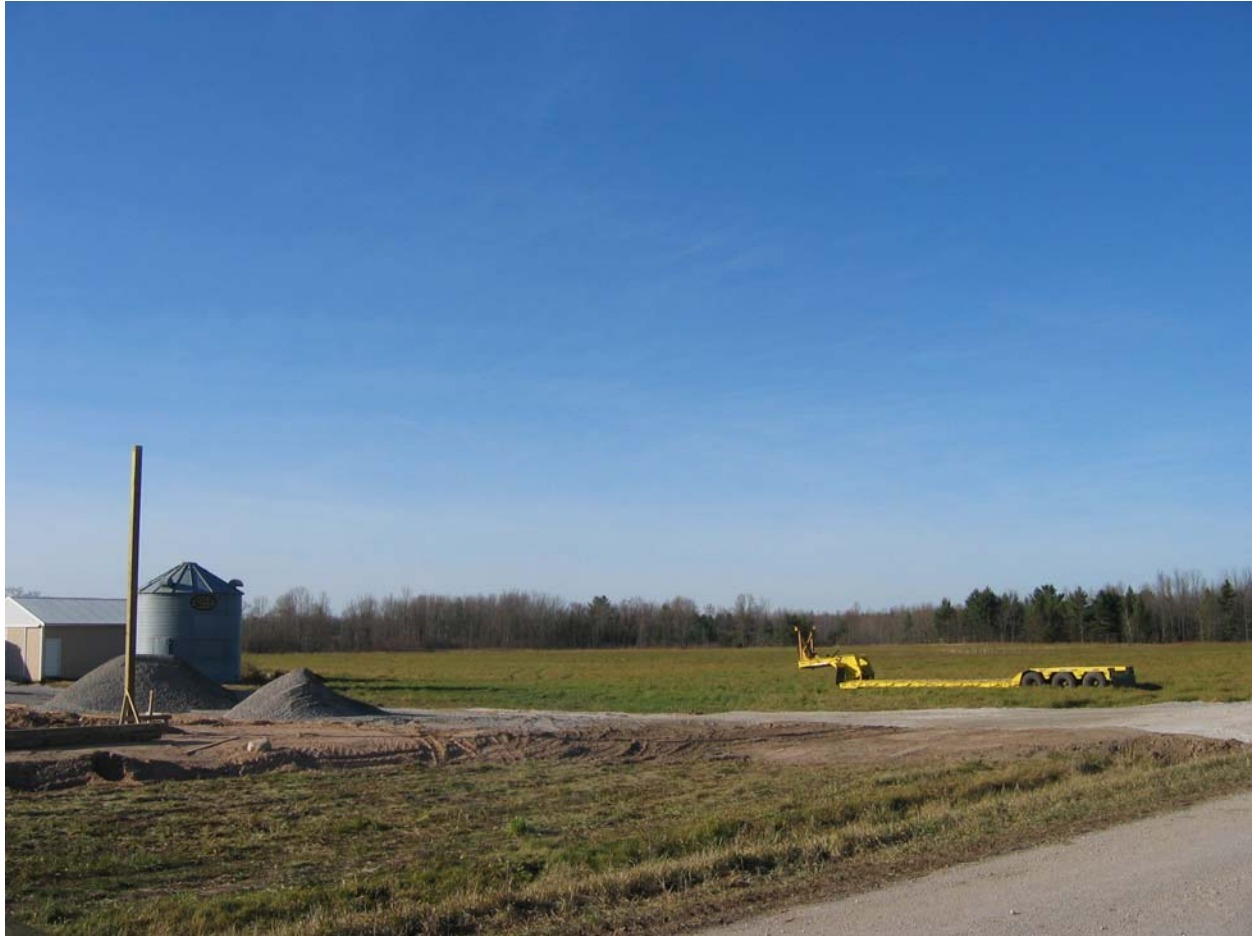
Site ID	Ag 16	Date	11/4/2009
Location		Farm Information	
Waterbody:	Haynes Creek	Type of Operation:	Crops
County:	Alcona	Riparian Frontage (ft):	4000
Township:	Haynes	Distance to Water (ft):	25
Town/Range:	27N / 9E	Soil Type:	Loam
Section(s):	17	Contamination Risks:	None
Natural Resource Concern(s)		Recommended Treatments(s)	
None		None	
Severity	Minor	Cost	NA

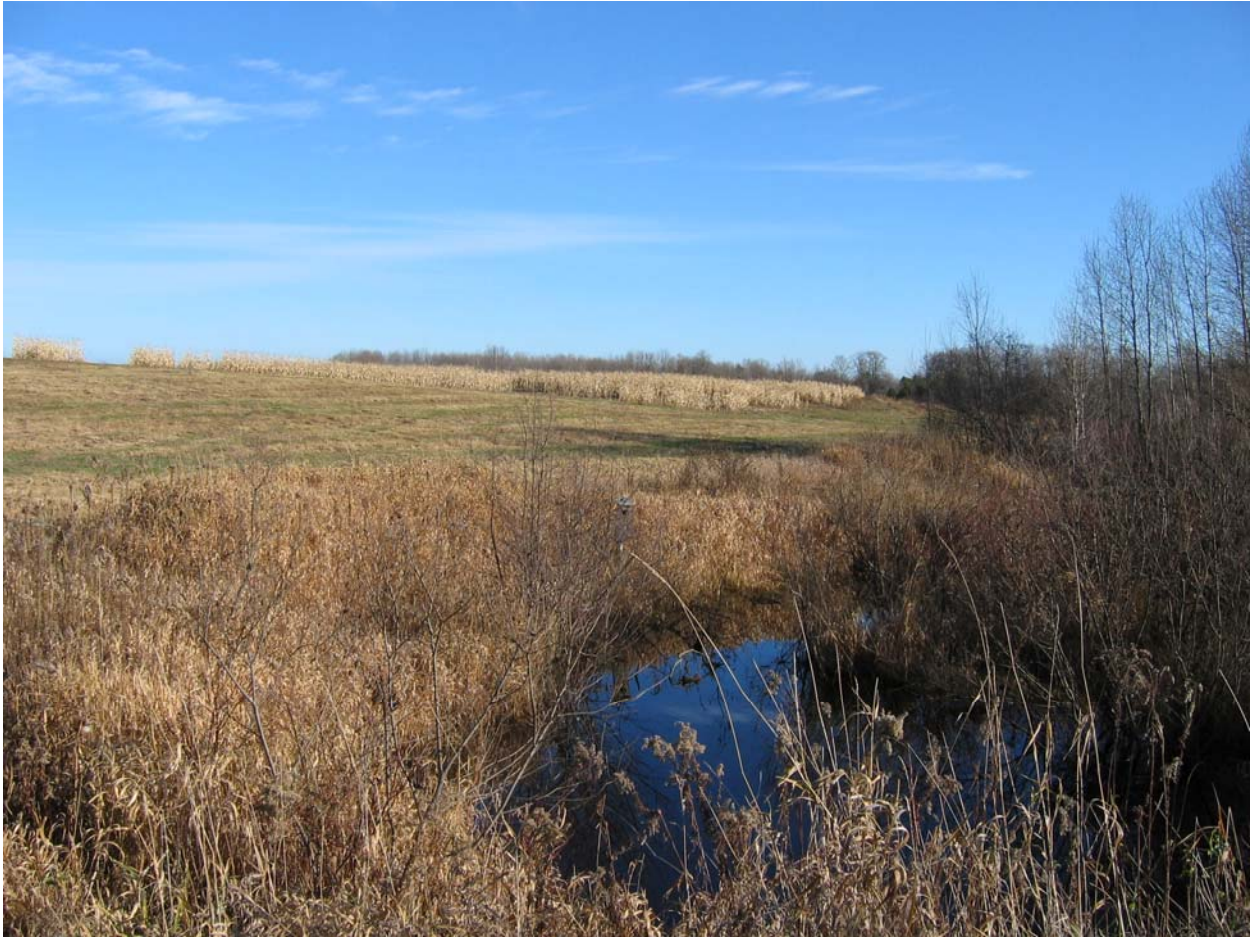
Site ID	Ag 17	Date	11/4/2009
Location		Farm Information	
Waterbody:	Haynes Creek	Type of Operation:	Crops
County:	Alcona	Riparian Frontage (ft):	600
Township:	Haynes	Distance to Water (ft):	25
Town/Range:	27N / 9E	Soil Type:	Loam
Section(s):	16	Contamination Risks:	None
Natural Resource Concern(s)		Recommended Treatments(s)	
None		None	
Severity	Minor	Cost	NA

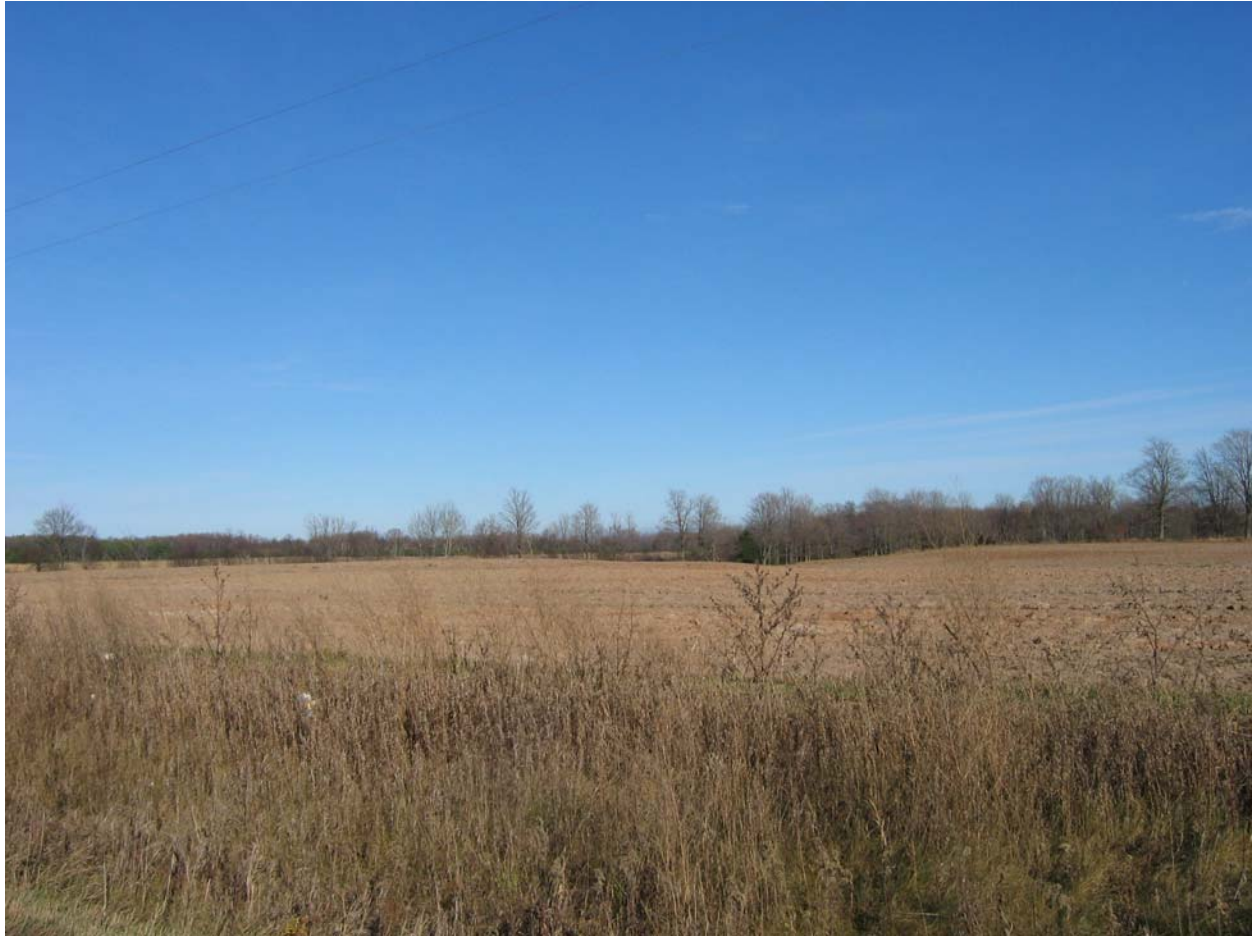
Site ID	Ag 18	Date	11/4/2009
Location		Farm Information	
Waterbody:	Haynes Creek	Type of Operation:	Crops
County:	Alcona	Riparian Frontage (ft):	4000
Township:	Haynes	Distance to Water (ft):	50
Town/Range:	27N / 9E	Soil Type:	Clay, Loam
Section(s):	16, 21	Contamination Risks:	None
Natural Resource Concern(s)		Recommended Treatments(s)	
None		None	
Severity	Minor	Cost	NA

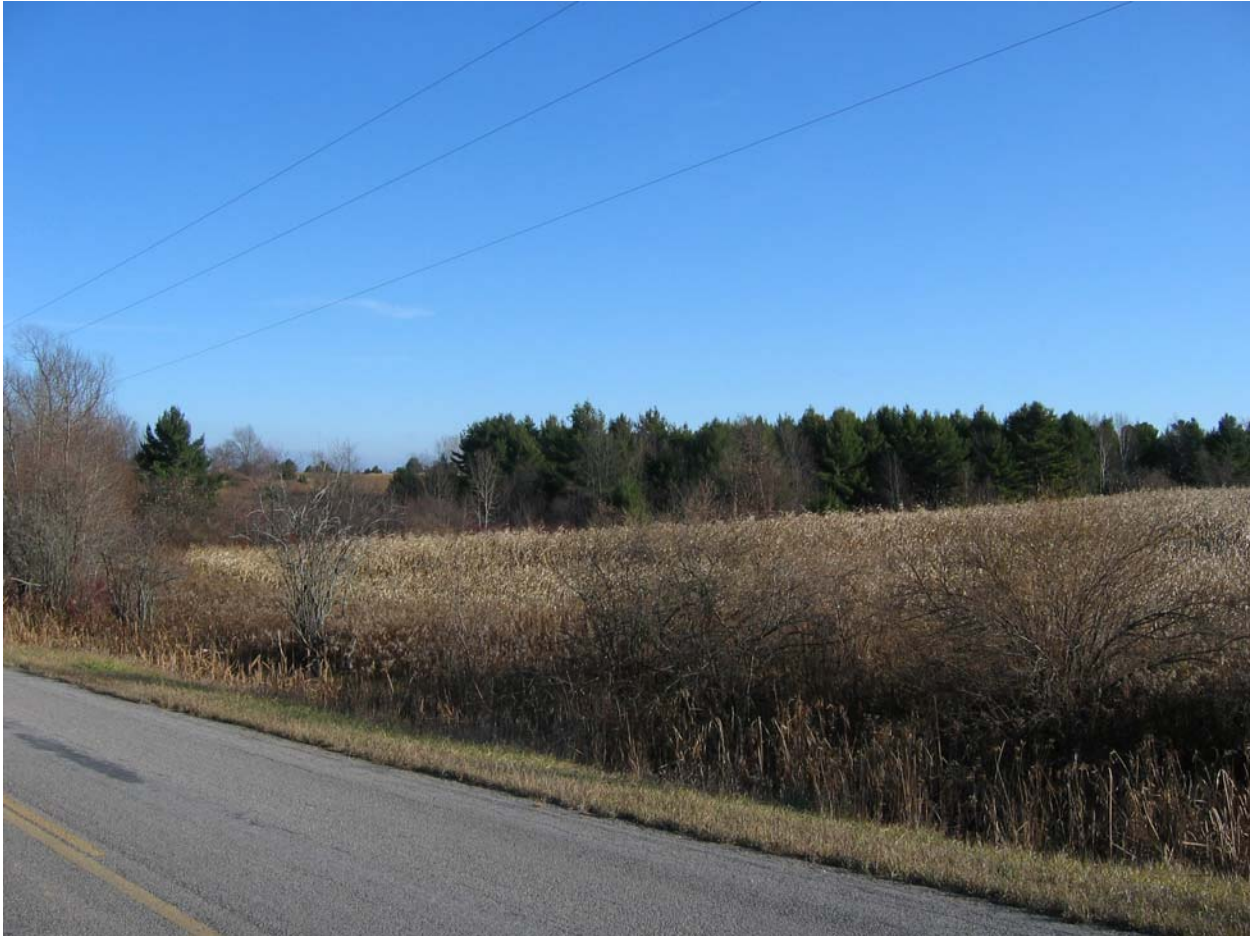
Site ID	Ag 19	Date	11/4/2009
Location		Farm Information	
Waterbody:	SB Black River Tributary	Type of Operation:	Crops
County:	Alcona	Riparian Frontage (ft):	1300
Township:	Haynes	Distance to Water (ft):	25
Town/Range:	27N / 9E	Soil Type:	Loam
Section(s):	9	Contamination Risks:	None
Natural Resource Concern(s)		Recommended Treatments(s)	
None		None	
Severity	Minor	Cost	NA

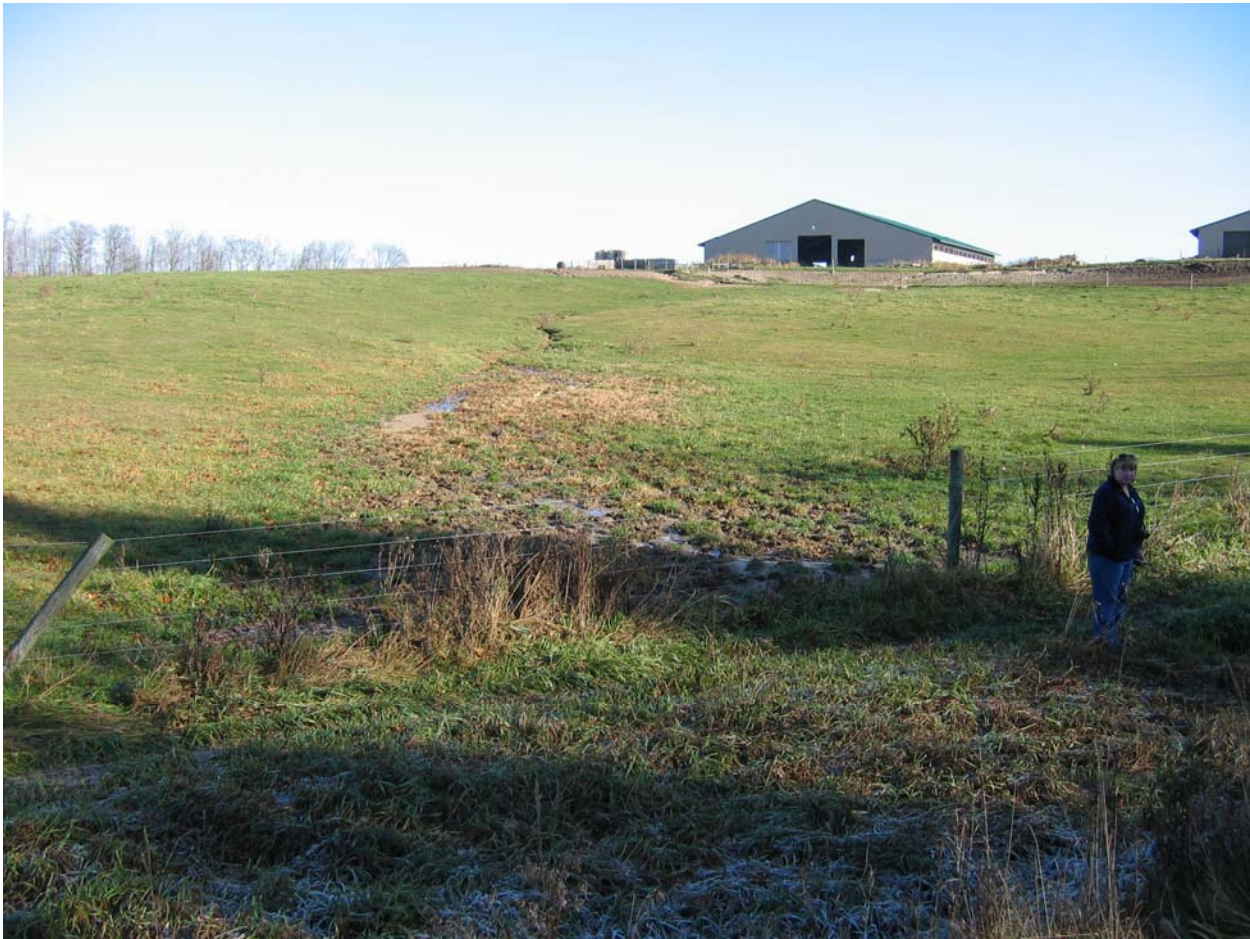
Site ID	Ag 20	Date	11/12/2009
Location		Farm Information	
Waterbody:	Butternut Creek Tributary	Type of Operation:	Livestock
County:	Alcona	Riparian Frontage (ft):	
Township:	Caledonia	Distance to Water (ft):	
Town/Range:	28N / 8E	Soil Type:	Loam
Section(s):	1	Contamination Risks:	
Natural Resource Concern(s)		Recommended Treatments(s)	
Small feedlot & pasture area drains to intermittent tributary to Butternut Crk. Approx 800' to tributary through wooded area, and 1 mile to Butternut Crk.		None – Unwilling landowner	
Severity	Minor	Cost	NA

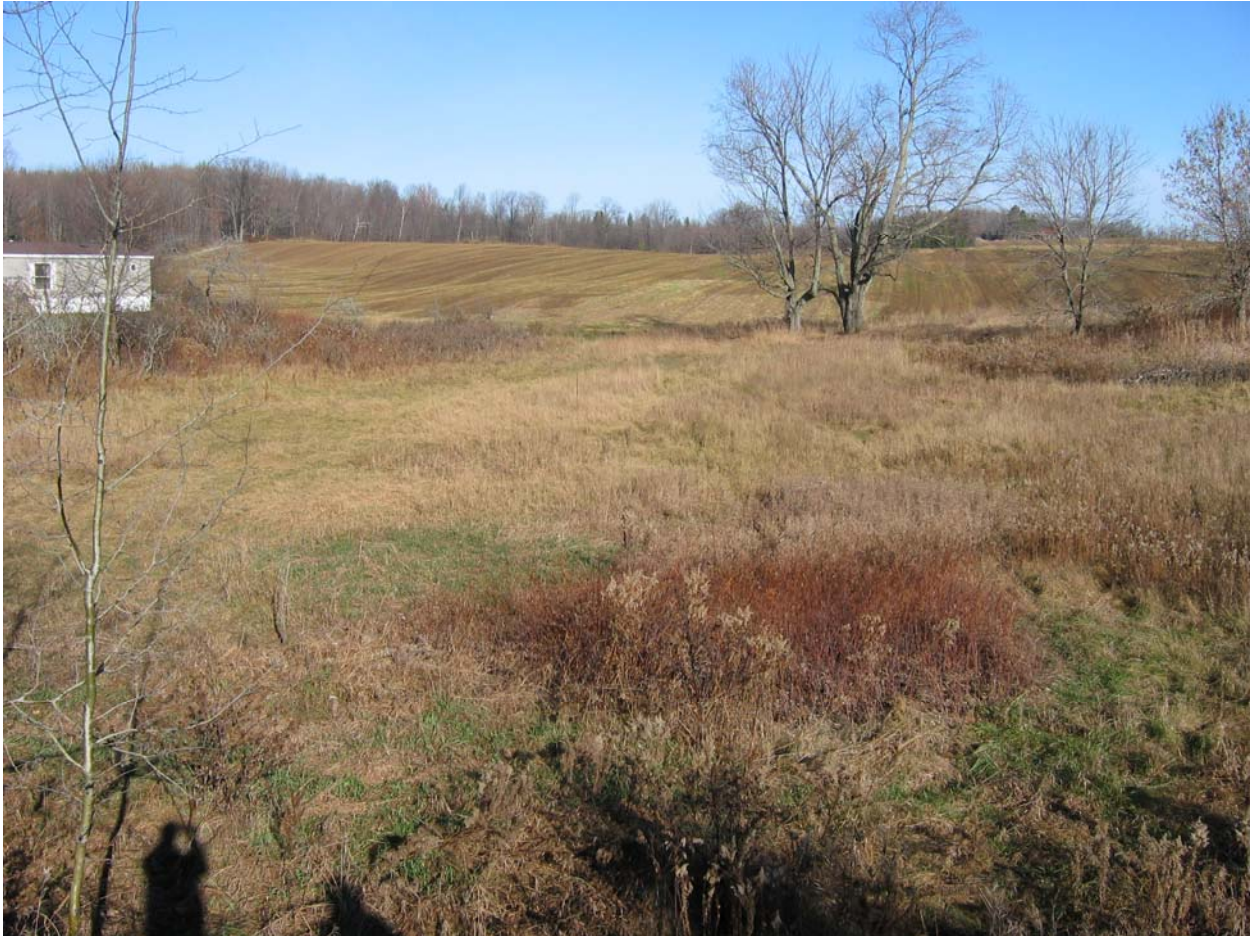
Site ID	Ag 21	Date	11/12/2009
Location		Farm Information	
Waterbody:	Butternut Creek Tributary	Type of Operation:	Crops
County:	Alcona	Riparian Frontage (ft):	1800
Township:	Caledonia	Distance to Water (ft):	50
Town/Range:	28N / 8E	Soil Type:	Loam
Section(s):	1	Contamination Risks:	None
Natural Resource Concern(s)		Recommended Treatments(s)	
None		None	
Severity	Minor	Cost	NA

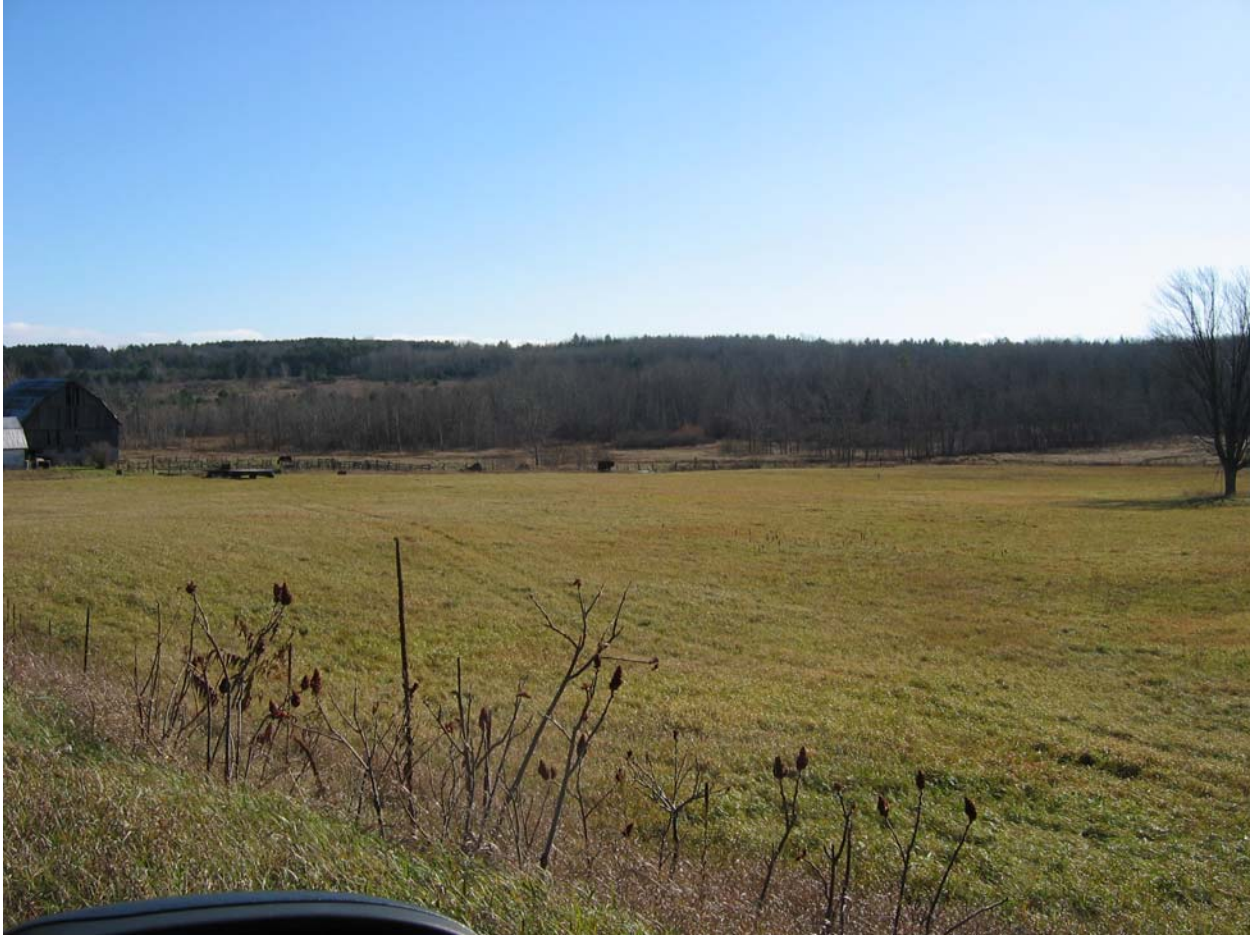
Site ID	Ag 22	Date	11/12/2009
Location		Farm Information	
Waterbody:	DeRoucher Creek	Type of Operation:	Crops, Livestock
County:	Alcona	Riparian Frontage (ft):	1600
Township:	Alcona	Distance to Water (ft):	200
Town/Range:	28N / 8E	Soil Type:	Loam
Section(s):	20	Contamination Risks:	None
Natural Resource Concern(s)		Recommended Treatments(s)	
None		None	
Severity	Minor	Cost	NA

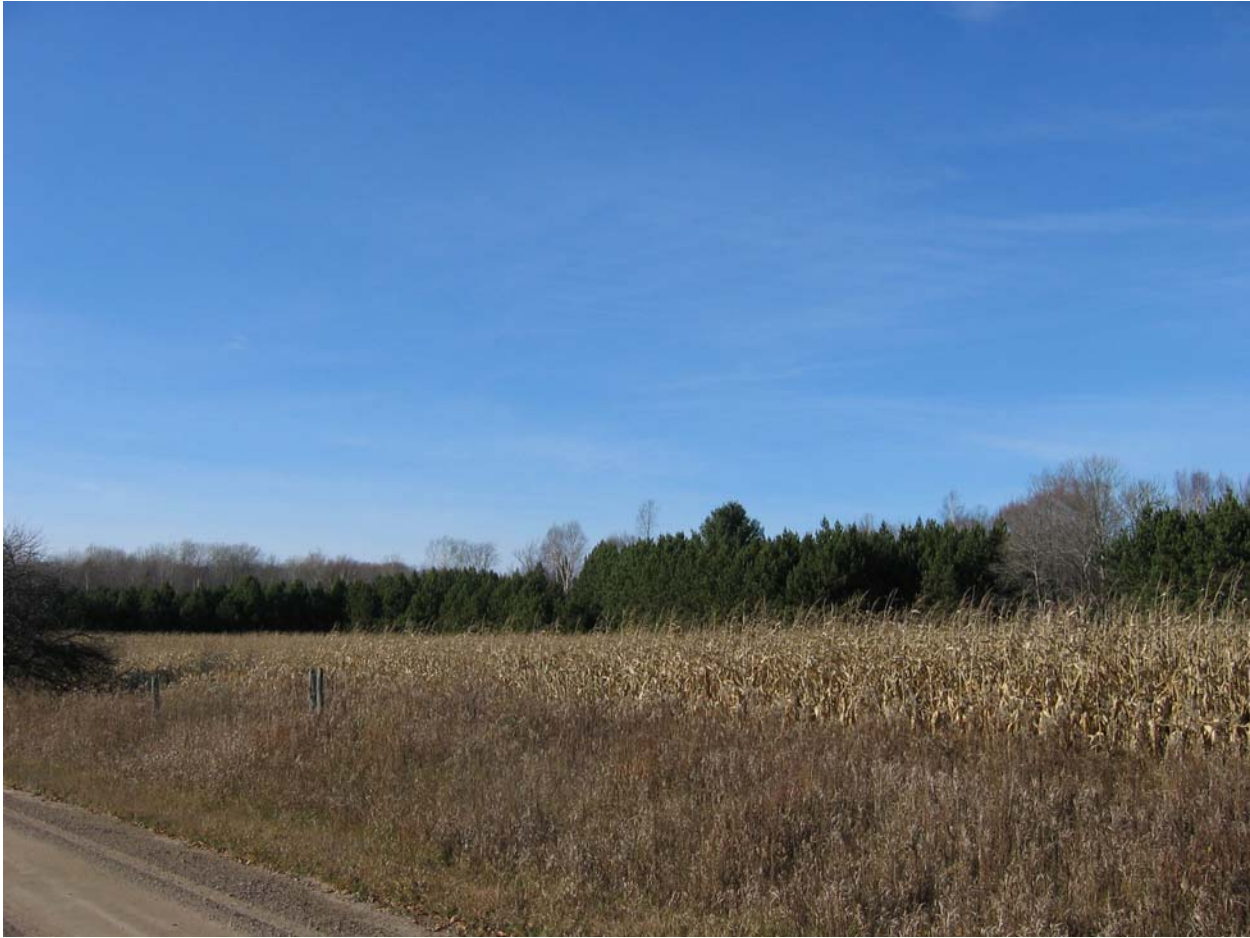
Site ID	Ag 23	Date	11/12/2009
Location		Farm Information	
Waterbody:	SB Black River	Type of Operation:	Crops
County:	Alcona	Riparian Frontage (ft):	2600
Township:	Haynes	Distance to Water (ft):	200
Town/Range:	27N / 9E	Soil Type:	Loam
Section(s):	27, 28	Contamination Risks:	None
Natural Resource Concern(s)		Recommended Treatments(s)	
None		None	
Severity	Minor	Cost	NA

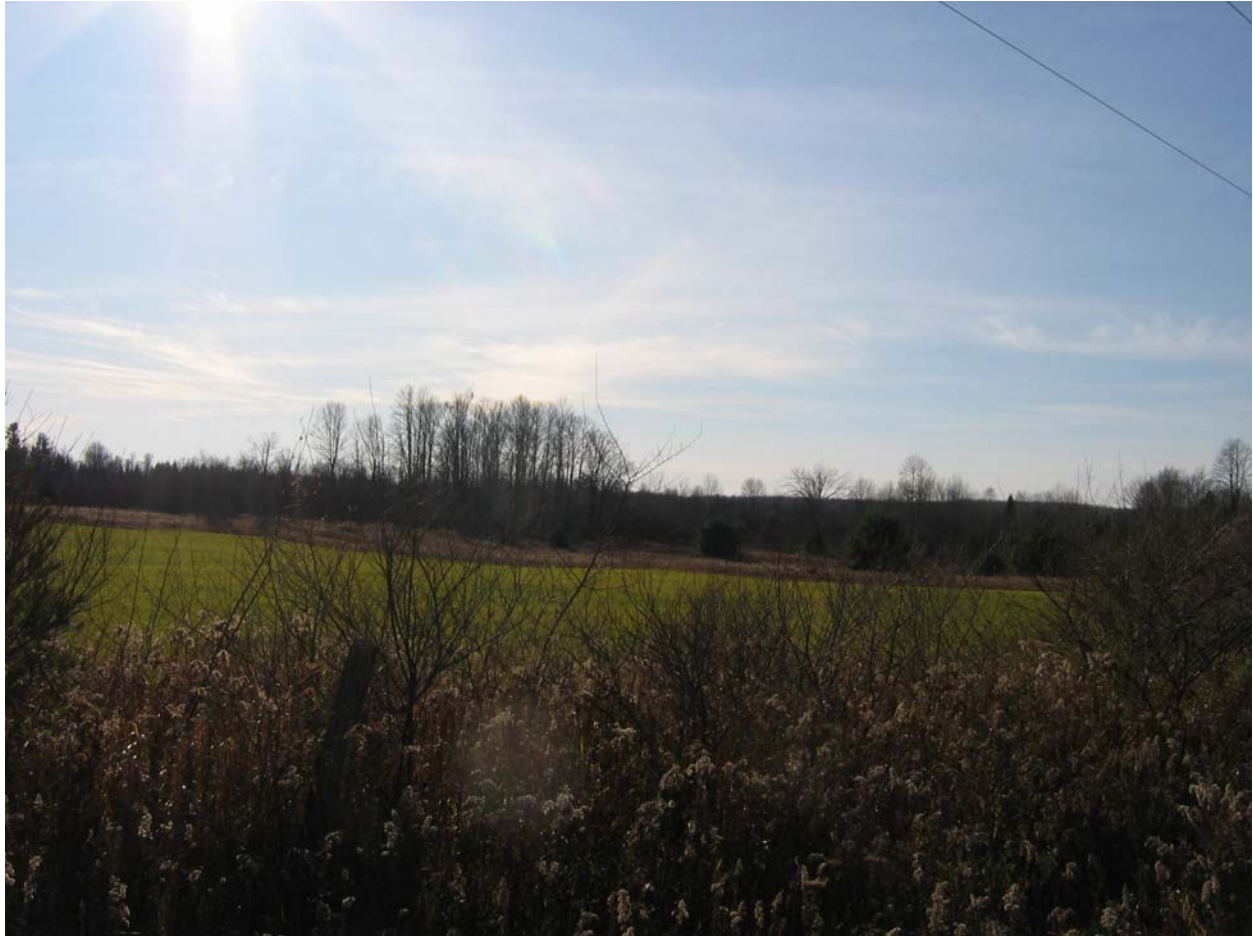
Site ID	Ag 24	Date	11/12/2009
Location		Farm Information	
Waterbody:	SB Black River	Type of Operation:	Crops
County:	Alcona	Riparian Frontage (ft):	1400
Township:	Haynes	Distance to Water (ft):	100 +
Town/Range:	27N / 9E	Soil Type:	Loam
Section(s):	33, 34	Contamination Risks:	None
Natural Resource Concern(s)		Recommended Treatments(s)	
None		None	
Severity	Minor	Cost	NA

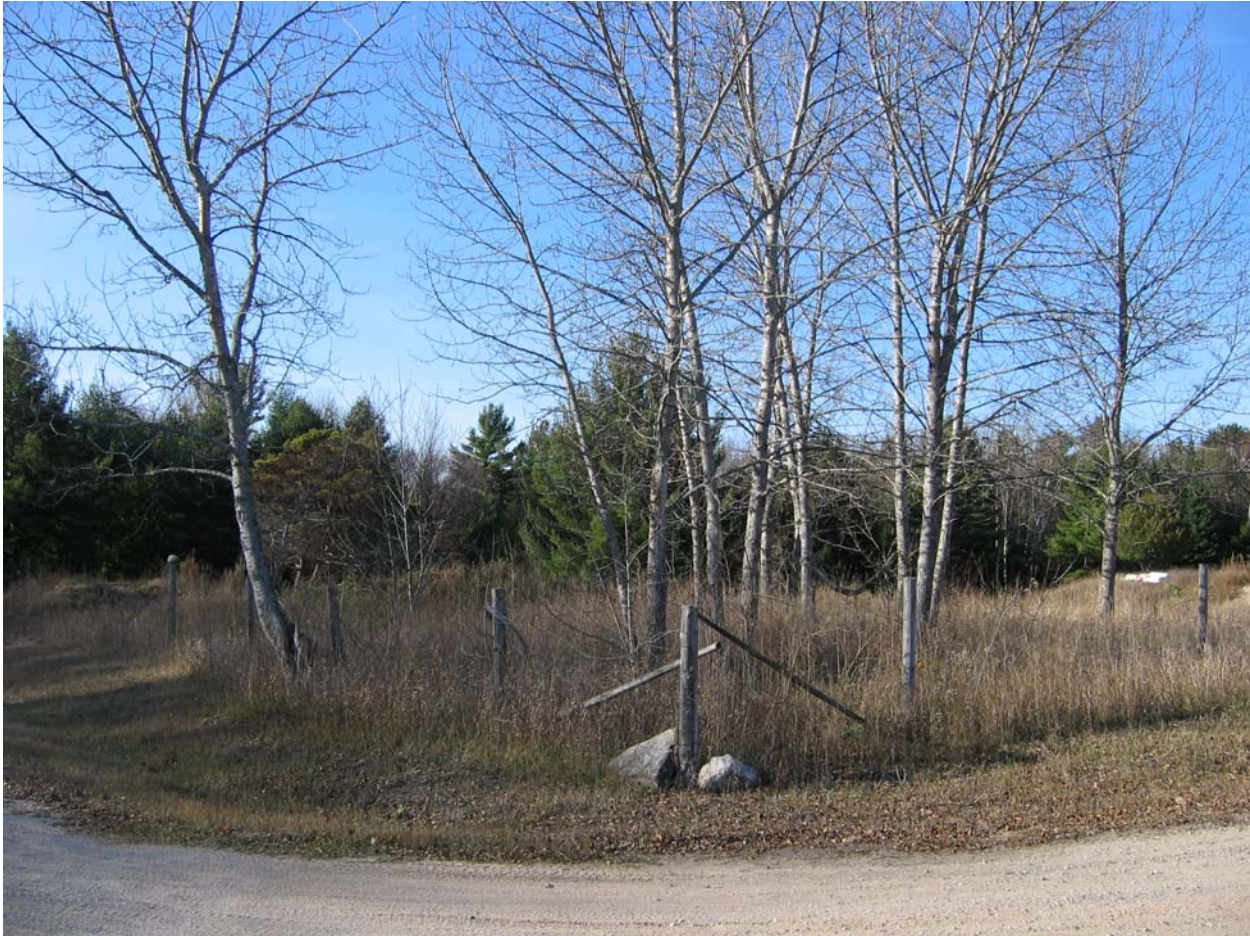
Site ID	Ag 25	Date	11/12/2009
Location		Farm Information	
Waterbody:	Haynes Creek	Type of Operation:	Crops
County:	Alcona	Riparian Frontage (ft):	1000
Township:	Haynes	Distance to Water (ft):	200 +
Town/Range:	27N / 9E	Soil Type:	Loam, Sand
Section(s):	21	Contamination Risks:	None
Natural Resource Concern(s)		Recommended Treatments(s)	
None		None	
Severity	Minor	Cost	NA

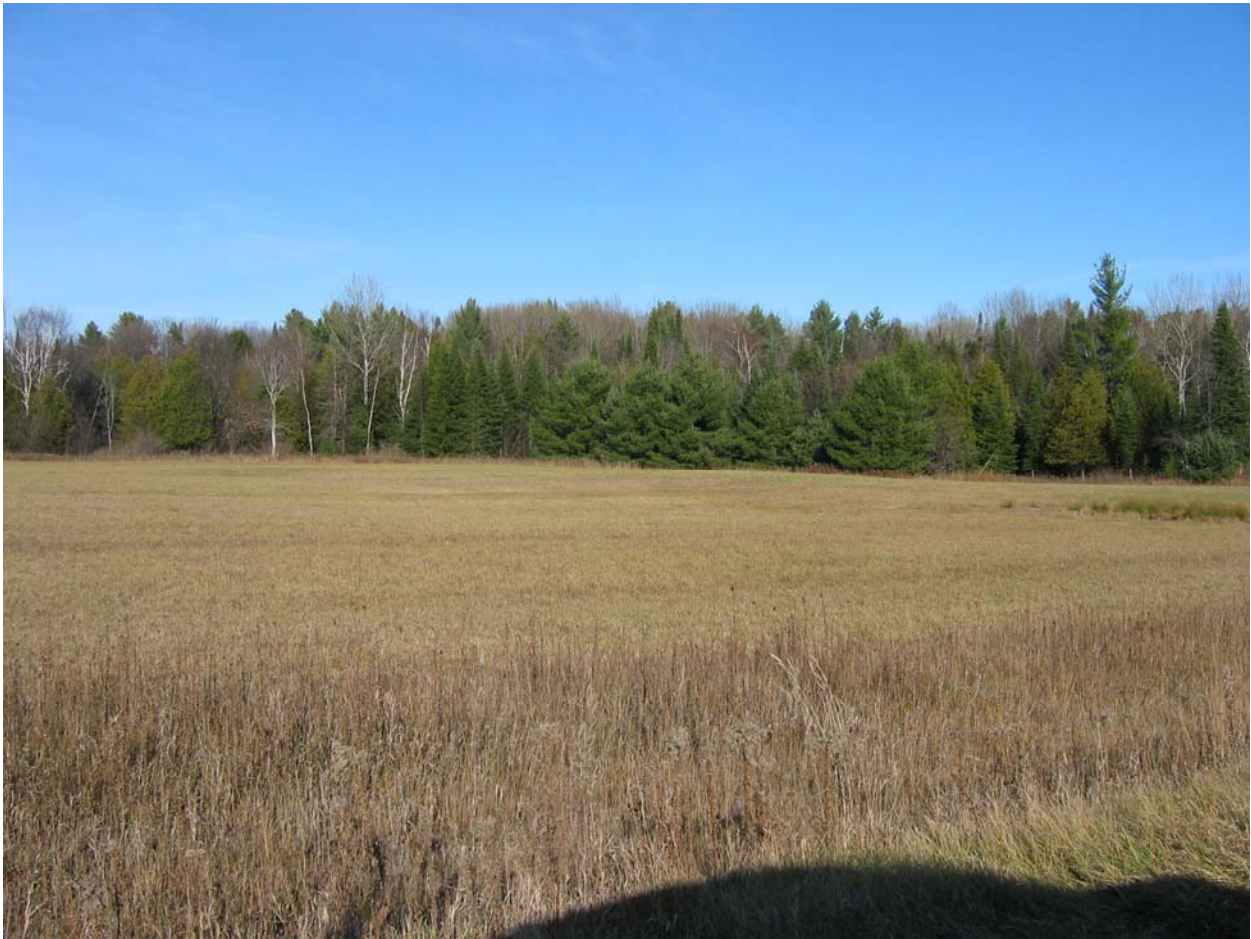
Site ID	Ag 26	Date	11/12/2009
Location		Farm Information	
Waterbody:	Haynes Creek	Type of Operation:	Crops
County:	Alcona	Riparian Frontage (ft):	500
Township:	Haynes	Distance to Water (ft):	100 +
Town/Range:	27N / 9E	Soil Type:	Loam
Section(s):	21	Contamination Risks:	None
Natural Resource Concern(s)		Recommended Treatments(s)	
None		None	
Severity	Minor	Cost	NA

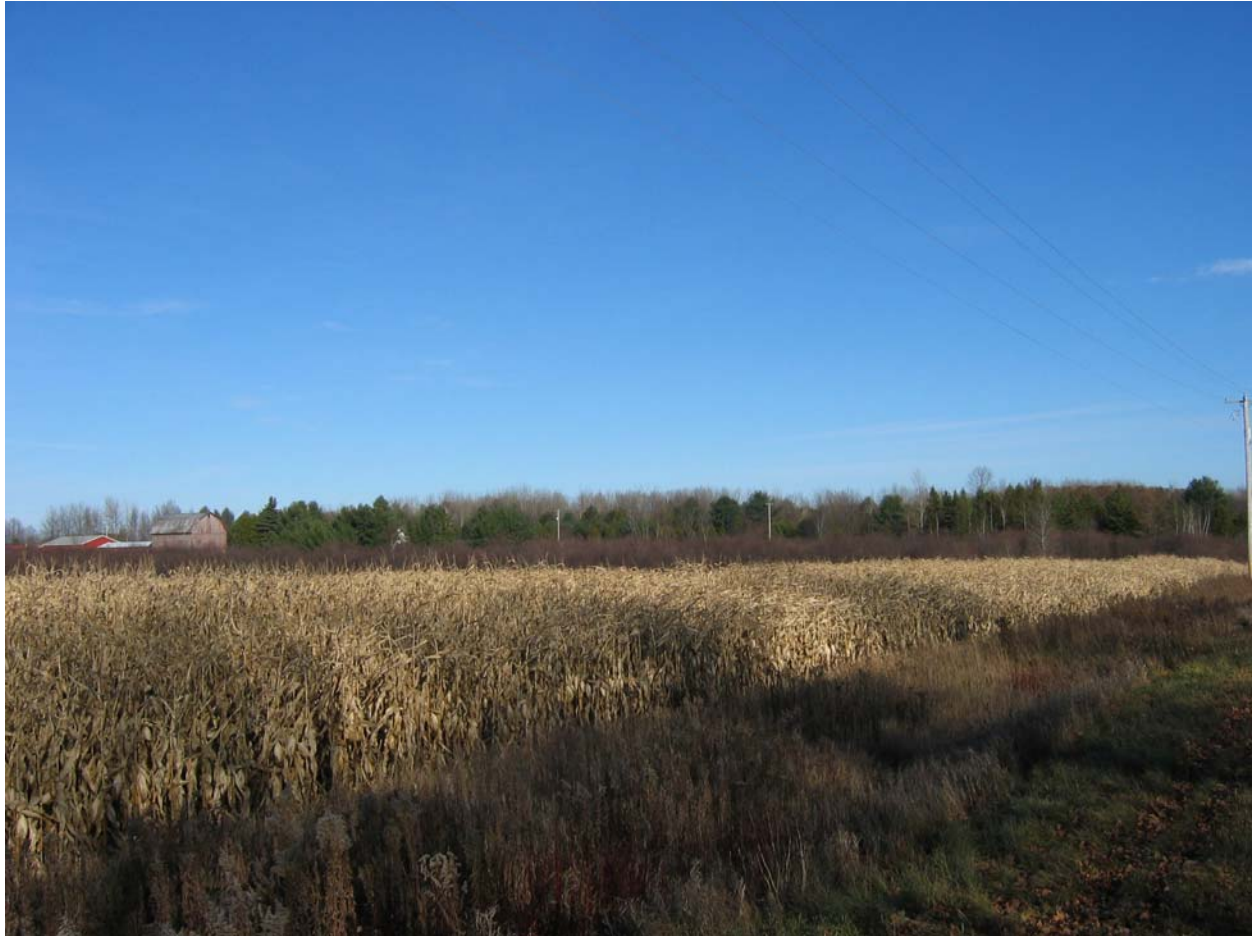
Site ID	Ag 27	Date	11/12/2009
Location		Farm Information	
Waterbody:	Haynes Creek Tributary	Type of Operation:	Crops
County:	Alcona	Riparian Frontage (ft):	2600
Township:	Haynes	Distance to Water (ft):	50
Town/Range:	27N / 9E	Soil Type:	Loam
Section(s):	8	Contamination Risks:	None
Natural Resource Concern(s)		Recommended Treatments(s)	
None		None	
Severity	Minor	Cost	NA

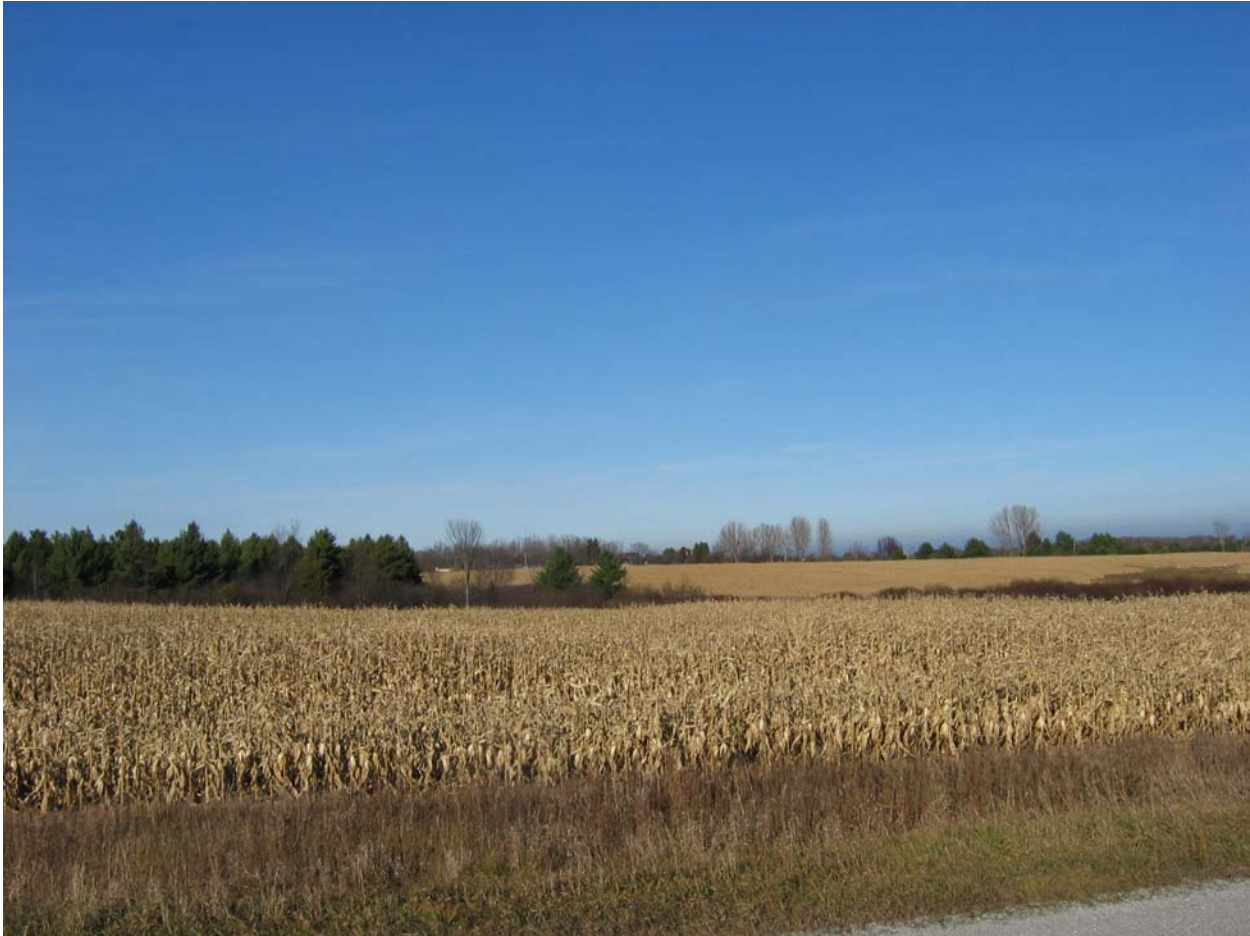
Site ID	Ag 28	Date	11/12/2009
Location		Farm Information	
Waterbody:	SB Black River Tributary	Type of Operation:	Crops
County:	Alcona	Riparian Frontage (ft):	2000
Township:	Haynes	Distance to Water (ft):	50
Town/Range:	27N / 9E	Soil Type:	Loam
Section(s):	9	Contamination Risks:	None
Natural Resource Concern(s)		Recommended Treatments(s)	
None		None	
Severity	Minor	Cost	NA

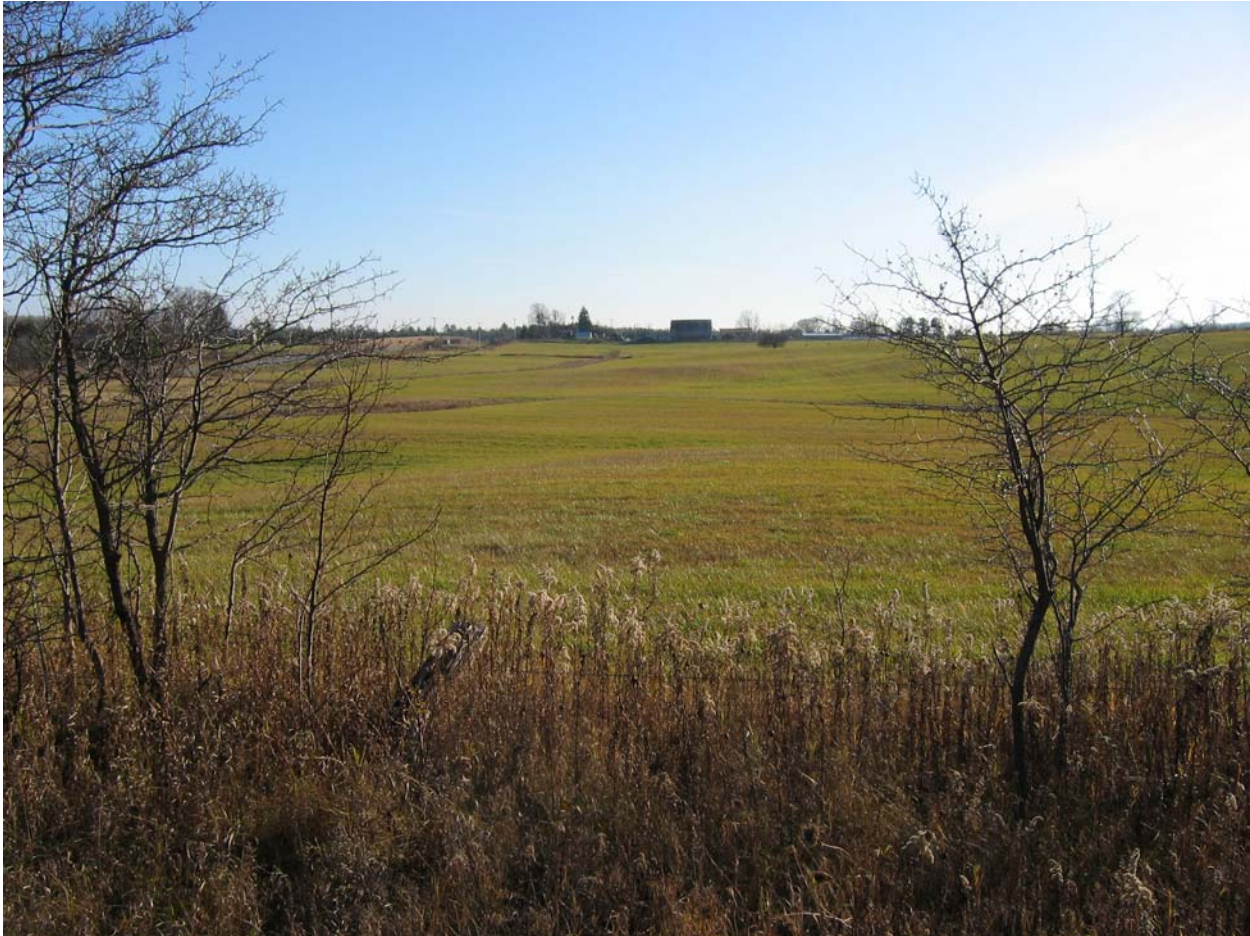
Site ID	Ag 29	Date	11/12/2009
Location		Farm Information	
Waterbody:	SB Black River Tributary	Type of Operation:	Crops
County:	Alcona	Riparian Frontage (ft):	6000
Township:	Haynes	Distance to Water (ft):	50
Town/Range:	27N / 9E	Soil Type:	Loam
Section(s):	10	Contamination Risks:	None
Natural Resource Concern(s)		Recommended Treatments(s)	
None		None	
Severity	Minor	Cost	NA
